# Parking Garage Expansion Joints

ID: 9487

**Application:** GSS-Gaskets, Seals and Shims

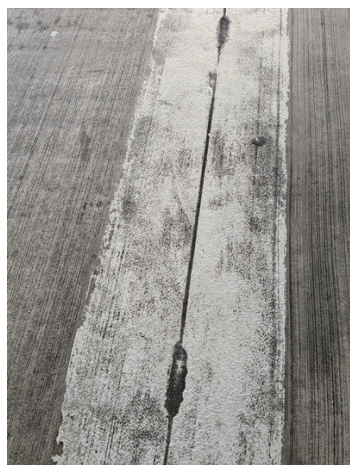
The expansion joints were leaking water into storage rooms underneath the parking garage when it rained.

Close-up of the expansion joint. Finished application. needing repair.

The old material in the expansion joints were removed. Then the joints were taped off. Then new backer-rod was placed in the joints. Then the conditioner ( Belzona 4911) was applied. Then the Belzona filler (4521) was applied to fill the joints.

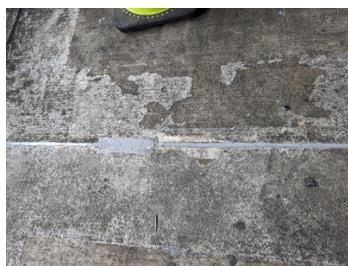
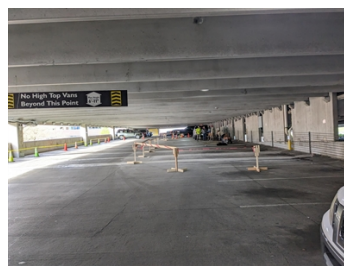
This is a pic of before the work was done.
