# Parking Garage Expansion Joints

ID: 9487

Application: *GSS-Gaskets, Seals and Shims*

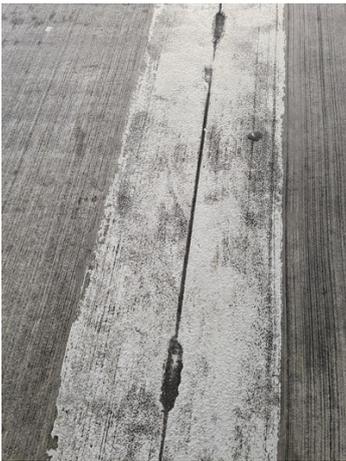
*The expansion joints were leaking water into storage rooms underneath the parking garage when it rained.*

Close-up of the expansion joint needing repair. Finished application.

This is a pic of before the work was done.

The old material in the expansion joints were removed. Then the joints were taped off. Then new backer-rod was placed in the joints. Then the conditioner ( Belzona 4911) was applied. Then the Belzona filler (4521) was applied to fill the joints.
