Water Treatment Plant Bund

Industry: Power
Application: TCC-Tanks and Chemical Containment Areas
Substrate: Concrete
Products: Belzona 4131 (Magma-Screed), Belzona 4311 (Magma CR1), Belzona 4911 (Magma TX Conditioner)

Customer Location: Leeds ERF Plant
Application Date: July 2022

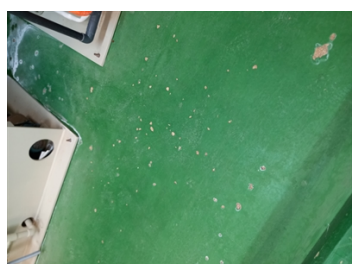
The original bund coating had failed after a short time in service, resulting in areas of exposed concrete within the banded area. The bund held a mixture of chemical storage tanks and dosing equipment. The chemicals contained within the bund were Hydrochloric Acid, Sodium Hydroxide and Caustic Soda.

Original Bund Coating with areas of exposed Concrete

Any existing loose coating was removed by mechanical/ and manual means.

Areas of exposed concrete were also taken back to sound material.

The whole bund was then prepared by the use of floor grinders to provide a suitable key for coating. all dust was then removed by vacuuming.

Areas of damaged concrete were repaired using Belzona 4131 (Magma Screed), the same product was also used to install a 50mm/50mm fillet around the bund walls and equipment.

Belzona 4911 (Magma TX Conditioner) was then applied, immediately followed by Belzona 2 coats of Belzona 4311 (Magma CR1). The system was then allowed to cure.

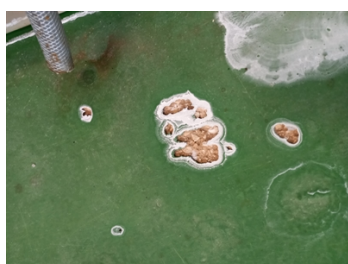
Original Bund Coating with areas of exposed Concrete

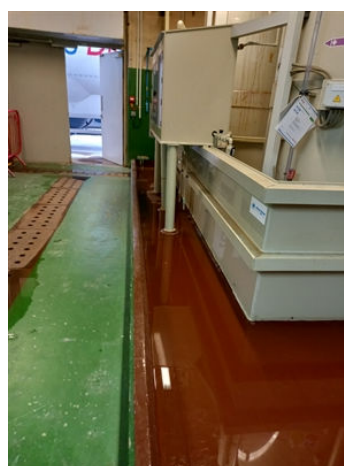
The Belzona Coating after 2 years in service showing no signs of deterioration, even after the occasional leak.

The coating was inspected after 2 years of service, and was showing no signs of deterioration.
