Water Treatment Plant Bund

Industry: Power
Application: TCC-Tanks and Chemical Containment Areas
Substrate: Concrete
Products: Belzona 4131 (Magma-Screed), Belzona 4311 (Magma CR1), Belzona 4911 (Magma TX Conditioner)

Customer Location: Leeds ERF Plant
Application Date: July 2022

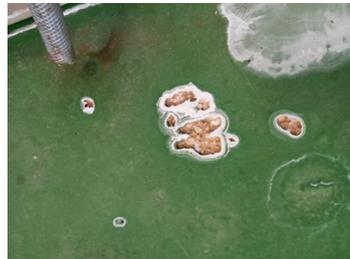
The original bund coating had failed after a short time in service, resulting in areas of exposed concrete within the banded area. The bund held a mixture of chemical storage tanks and dosing equipment.

Original Bund Coating with areas of exposed Concrete

Any existing loose coating was removed by mechanical/ and manual means.

Areas of exposed concrete were also taken back to sound material.

The whole bund was then prepared by the use of floor grinders to provide a suitable key for coating. all dust was then removed by vacuuming.

Areas of damaged concrete were repaired using Belzona 4131 (Magma Screed), the same product was also used to install a 50mm/50mm fillet around the bund walls and equipment.

Belzona 4911 (Magma TX Conditioner) was then applied, immediately followed by Belzona 2 coats of Belzona 4311 (Magma CR1). The system was then allowed to cure.

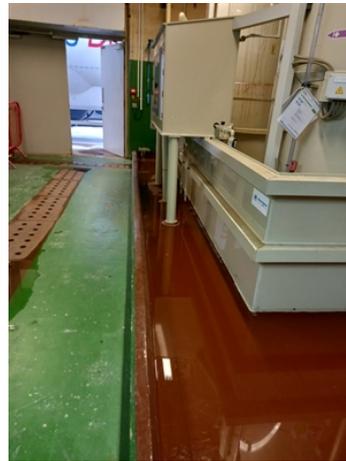
Original Bund Coating with areas of exposed Concrete

The Belzona Coating after 2 years in service showing no signs of deterioration, even after the occasional leak.

The coating was inspected after 2 years of service, and was showing no signs of deterioration.
