Water Treatment Plant Bund

Industry: Power
Application: TCC-Tanks and Chemical Containment Areas
Substrate: Concrete
Products: Belzona 4131 (Magma-Screed), Belzona 4311 (Magma CR1), Belzona 4911 (Magma TX Conditioner)

Customer Location: Leeds ERF Plant
Application Date: July 2022

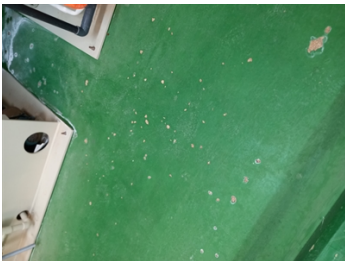
The original bund coating had failed after a short time in service, resulting in areas of exposed concrete within the banded area. The bund held a mixture of chemical storage tanks and dosing equipment.

Original Bund Coating with areas of exposed Concrete

Any existing loose coating was removed by mechanical/ and manual means.

Areas of exposed concrete were also taken back to sound material.

The whole bund was then prepared by the use of floor grinders to provide a suitable key for coating. all dust was then removed by vacuuming.

Areas of damaged concrete were repaired using Belzona 4131 (Magma Screed), the same product was also used to install a 50mm/50mm fillet around the bund walls and equipment.

Belzona 4911 (Magma TX Conditioner) was then applied, immediately followed by Belzona 2 coats of Belzona 4311 (Magma CR1) The system was then allowed to cure.

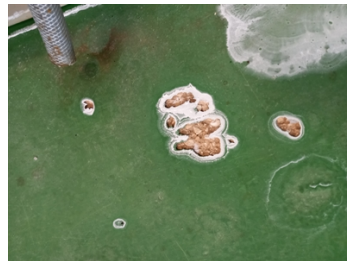
Original Bund Coating with areas of exposed Concrete

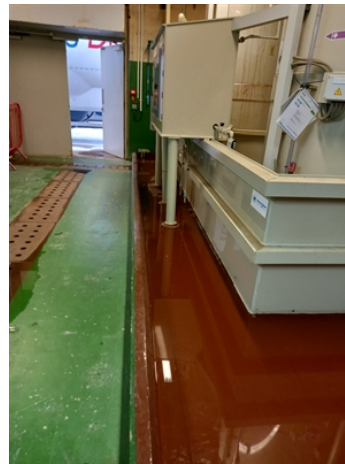
The Belzona Coating after 2 years in service showing no signs of deterioration, even after the occasional leak.

The coating was inspected after 2 years of service, and was showing no signs of deterioration.
