24inch Pipe Leak Repair of Using Belzona 1212 and SuperWrap II

ID: 9489

Industry: Oil & Gas
Application: VPF-Valves, Pipes and Fittings
Substrate: Carbon steel
Products: Belzona 1212, Belzona SuperWrap II

Customer Location: Wafra, Kuwait
Application Date: July 2024

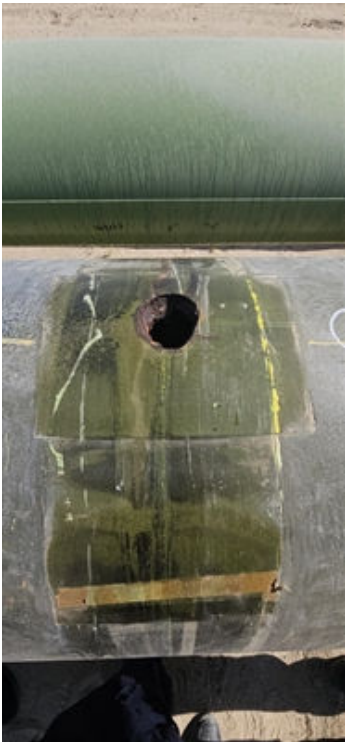
The client is experiencing wall thickness loss which has led to a 6-7 cm hole in the 24-inch crude oil pipeline. The excessive erosion and corrosion of the crude oil is causing the leaks. The pipeline is operating at ambient temperature and a pressure of up to 5 bar.

Pipe defect prior to Belzona application

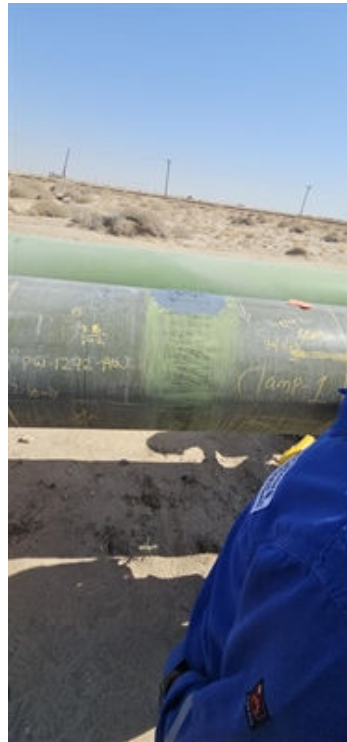
Steel plate bonded using Belzona 1212

Surface preparation was completed using power tools. Belzona 1212 along with patch plates were applied to seal the defect area. Once Belzona 1212 fully cured, Belzona Superwrap II application was carried out to consolidate the repair.

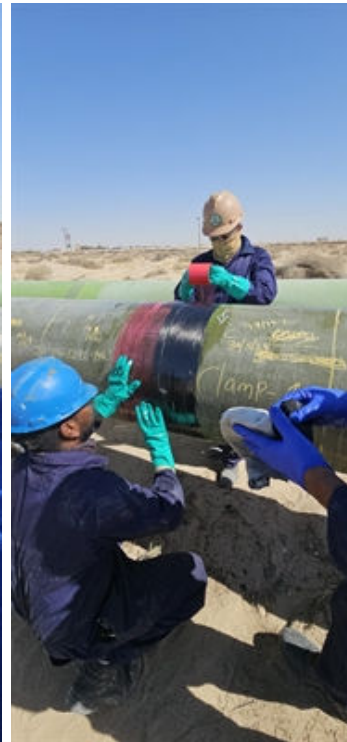
Application of Belzona Superwrap II

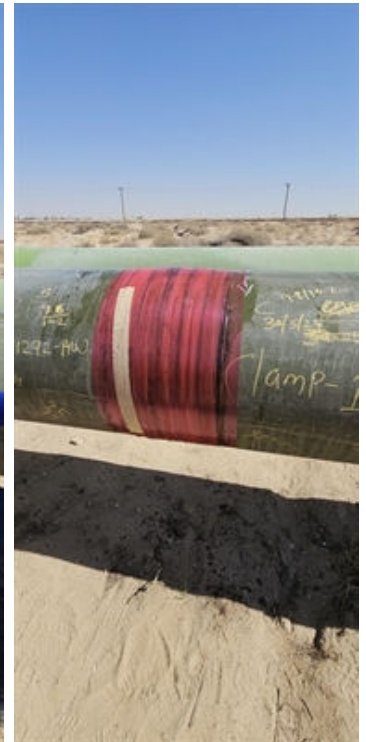
Completed Belzona Superwrap II repair

Superwrap II can be applied to the damaged area with minimal preparation, downtime, and without the need for hot work on site. The client was pleased with the performance of Superwrap II and approved its addition as part of their maintenance procedures.
