BELZONA PROTECTS DRUM THICKENERS AGAINST CORROSION

Industry: Water / Wastewater
Application: TCC-Tanks and Chemical Containment Areas
Substrate: Carbon Steel
Products: * Belzona® 1111 Super-Metal ,
* Belzona® 5811 Immersion Grade ,

Customer Location: Wastewater Treatment Plant - UK
Application Date: August 2007

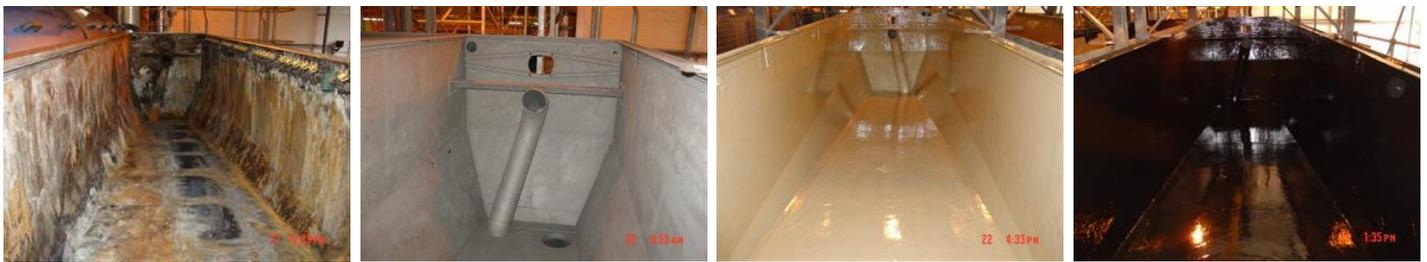
Photograph Descriptions

The mechanical drum thickener casings at this plant had corroded in service from contact with Chlorides & Sulphates present in the wastewater sludge being processed.

- * Original corroded condition ,
- * Blasted ready for repair & coating ,
- * Belzona® 5811 first coat complete ,
- * Completed application ,

The application was carried out in accordance with Belzona System Leaflet TCC-5.

After grit blasting the units any pitting corrosion was filled with Belzona® 1111 followed by fully lining with two coats of Belzona® 5811. Following the successful completion of this set of Drum Thickeners, this company have since coated a second set using the same procedure.
