Patch Repairs to Ultrasonic Bath

Application: TCC-Tanks and Chemical Containment Areas

Substrate: Carbon steel

Products: Belzona 1391T, Belzona 1511 (Super HT-Metal), Belzona SuperWrap II

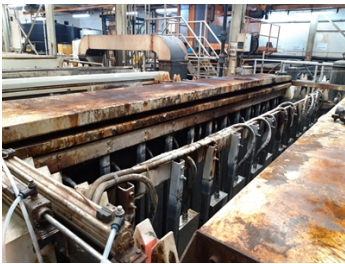
Location and environment

Having removed a weir plate some years ago which revealed damage and causing leakage from the bath. Repairs of the time have then failed with significant corrosion and through wall defects, resulting in referring back to the Belzona solution offered at the time.
