Patch Repairs to Ultrasonic Bath

ID: 9490

Industry: *Other*
Application: *TCC-Tanks and Chemical Containment Areas*
Substrate: *Carbon steel*
Products: *Belzona 1391T, Belzona 1511 (Super HT-Metal), Belzona SuperWrap II*

Customer Location: *Ebbw Vale South Wales*
Application Date: *June 2024*

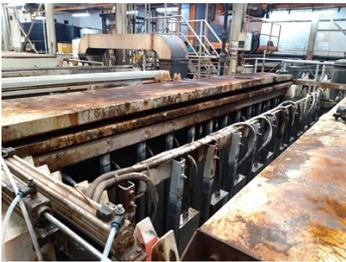
Location and environment

Having removed a weir plate some years ago which revealed damage and causing leakage from the bath. Repairs of the time have then failed with significant corrosion and through wall defects, resulting in referring back to the Belzona solution offered at the time.
