# Belzona 2111 covers the clips

Application: *SHM-Solids Handling Machinery*

Products: *Belzona 2111 (D & A Hi-Build Elastomer), Belzona 2911 (Elastomer QD Conditioner)*

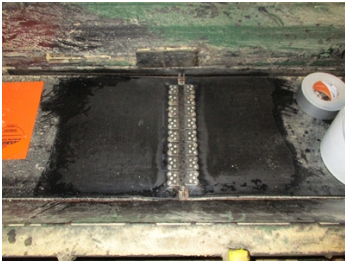
Application area cleaned.

Washed the belt and clip joint with soapy water and allowed it to dry. The surface of the rubber was roughened by hand using a roughing tool. Tape was applied to the outer edges, and over the center of the clip joint to allow it to continue to flex. Belzona 2911 QD Conditioner was applied and allowed to become touch dry following the instructions for use. Belzona 2111 was then applied, first being scrubbed into the roughened surface, then skim coated over the entire application area and smoothed off by hand to prevent any rough edges or corners.

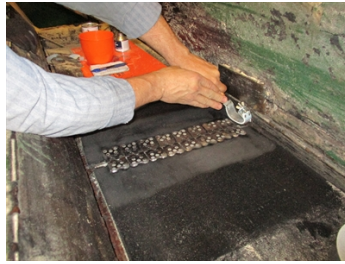
Roughening the surface by hand prior to applying the Belzona 2911 conditioner.

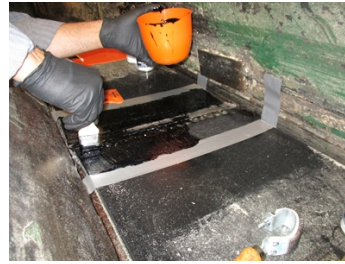
Scrubbing the Belzona 2111 into the application area.

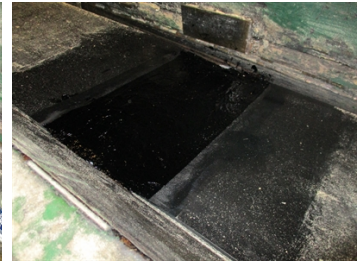
Completed application.

The clip joint on this belt was needing to be replaced every couple months to keep the belt operational. This belt moved lumber scraps in a lumber mill to the chipper and could have a wide variety of sizes of scrap wood on it. When this belt would fail, it would make a large mess of scrap wood and back up the production line until it was repaired. Applying Belzona 2111 over the clip joint protected the clips from wear and prevented the constant unscheduled shutdowns.

Using Belzona 2111 to cover the clip joint prevented countless unscheduled emergency shutdowns and overall reduced the cost of repetitive repairs. This repair paid for itself within one month of normal use at this lumber mill.
