# Belzona 2111 covers the clips

ID: 9491

Application: SHM-Solids Handling Machinery

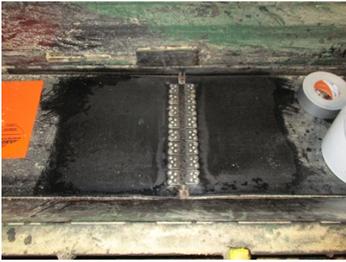
Application area cleaned.

Washed the belt and clip joint with soapy water and allowed it to dry. The surface of the rubber was roughened by hand using a roughing tool. Tape was applied to the outer edges, and over the center of the clip joint to allow it to continue to flex. Belzona 2911 QD Conditioner was applied and allowed to become touch dry following the instructions for use. Belzona 2111 was then applied, first being scrubbed into the roughened surface, then skim coated over the entire application area and smoothed off by hand to prevent any rough edges or corners.

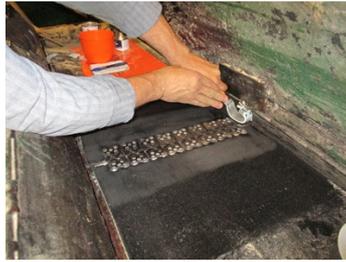
Roughening the surface by hand prior to applying the Belzona 2911 conditioner.

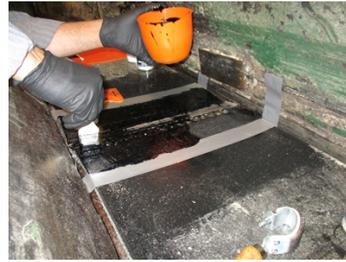
Scrubbing the Belzona 2111 into the application area.

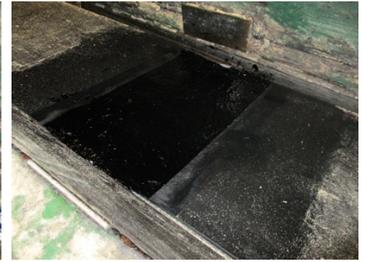
Completed application.

The clip joint on this belt was needing to be replaced every couple months to keep the belt operational. This belt moved lumber scraps in a lumber mill to the chipper and could have a wide variety of sizes of scrap wood on it. When this belt would fail, it would make a large mess of scrap wood and back up the production line until it was repaired. Applying Belzona 2111 over the clip joint protected the clips from wear and prevented the constant unscheduled shutdowns.

Using Belzona 2111 to cover the clip joint prevented countless unscheduled emergency shutdowns and overall reduced the cost of repetitive repairs. This repair paid for itself within one month of normal use at this lumber mill.
