Belzona 2111 covers the clips

ID: 9491

Application: *SHM-Solids Handling Machinery*

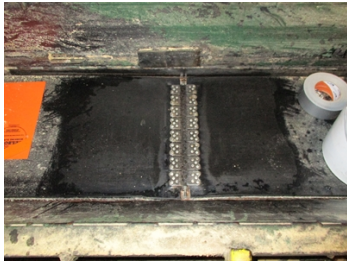
Application area cleaned.

Washed the belt and clip joint with soapy water and allowed it to dry. The surface of the rubber was roughened by hand using a roughing tool. Tape was applied to the outer edges, and over the center of the clip joint to allow it to continue to flex. Belzona 2911 QD Conditioner was applied and allowed to become touch dry following the instructions for use. Belzona 2111 was then applied, first being scrubbed into the roughened surface, then skim coated over the entire application area and smoothed off by hand to prevent any rough edges or corners.

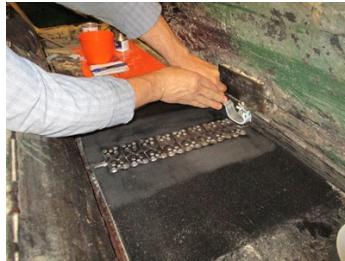
Roughening the surface by hand prior to applying the Belzona 2911 conditioner.

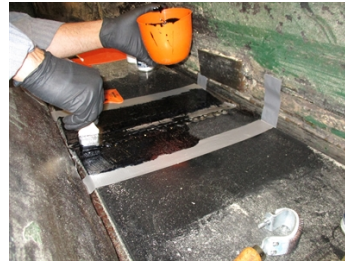
Scrubbing the Belzona 2111 into the application area.

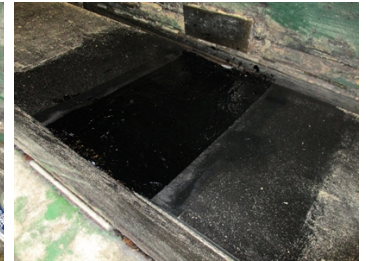
Completed application.

Using Belzona 2111 to cover the clip joint prevented countless unscheduled emergency shutdowns and overall reduced the cost of repetitive repairs. This repair paid for itself within one month of normal use at this lumber mill.
