Belzona Gives The Roller Traction

ID: 9492

Application: *SHM-Solids Handling Machinery*

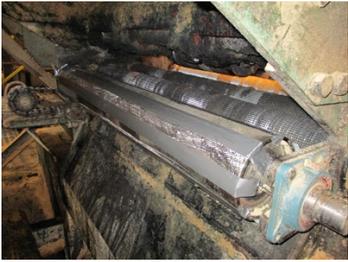
The roller with four sections taped off and hand ground, solvent washed and ready for application.

A 4" hand grinder was used to heavily roughen the surface where the application was going to be. The area was thoroughly washed with solvent, and the Belzona 1321 was applied in one heavy coat about 15-20 mils thick before having the Belzona 9221 aggregate sprinkled into it and gently packed down with a small board.

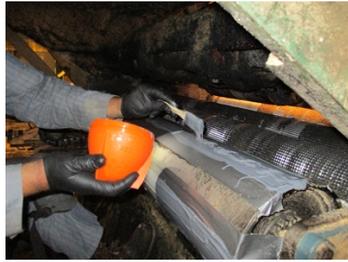
Applying a heavy layer of Belzona 1321 to the application zone before liberally sprinkling Belzona 9221 aggregate into it.

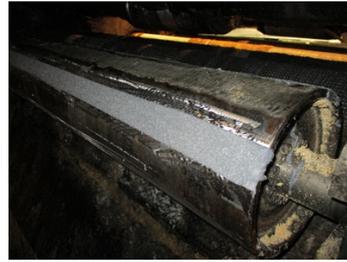
Belzona 9221 aggregate sprinkled into the Belzona 1321 to refusal and packed down.

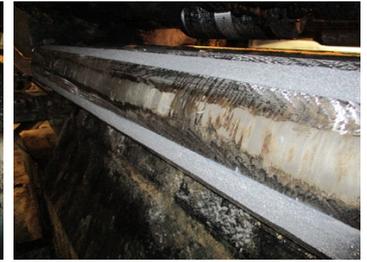
Application complete.

This drive roller was smooth which made it hard to move lumber with it. The customer chose to apply four strips of Belzona 1321 embedded with Belzona 9221 aggregate for positive grip. This allowed the lumber mill to be able to slow down the drive motor and reduce the cost of operation.

By solving the slipping problem, this lumber mill reduced its operating costs by being able to slow down the motor that turned this drive roller. The Belzona 9221 aggregate was chosen because of its finer particles which would not mar or damage the lumber that was being moved by the roller.
