Repair of PVC pipe with leak from failed fiber glass installation

ID: 9493

Application: *VPF-Valves, Pipes and Fittings*

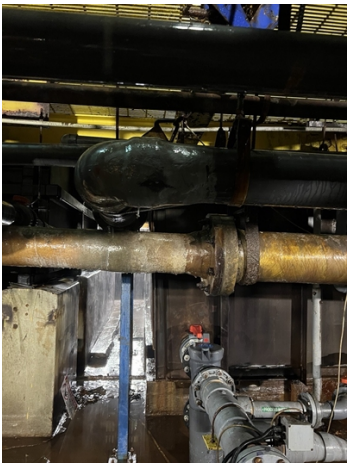
Major leaks was experienced from a failed fiber glass installed earlier by customer to fix problem.

Failed fiber glass

The failed fiber glass was abraded with the aid of a power tool after which the surface was wiped clean using the cleaner/ degreaser Belzona 9111. After drying, Belzona 1212 was mixed and apply with Belzona Super wrap installed afterwards.

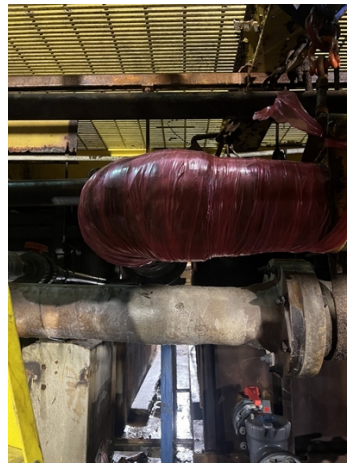
Newly installed Belzona Superwrap II

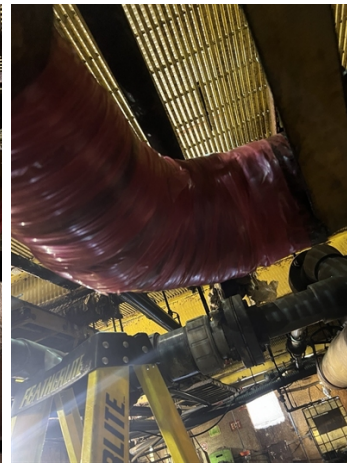
Belzona Super wrap installed successfully.

Belzona was not only able to seal the leak in a couple of minutes but also completed the whole installation and the equipment put back in service as stipulated in the product IFU. Follow up with customer confirmed that there was no leak or sipping as the Super wrap II successfully solve the issue.
