# Repair of PVC pipe with leak from failed fiber glass installation

ID: 9493

Application: *VPF-Valves, Pipes and Fittings*

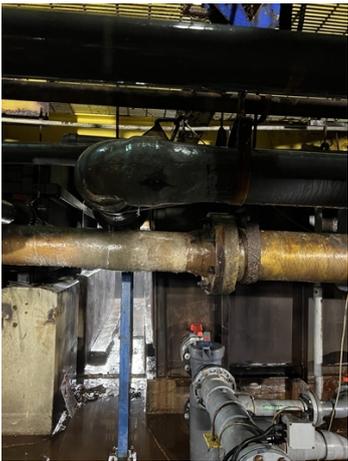
*Major leaks was experienced from a failed fiber glass installed earlier by customer to fix problem.*

Failed fiber glass

The failed fiber glass was abraded with the aid of a power tool after which the surface was wiped clean using the cleaner/ degreaser Belzona 9111. After drying, Belzona 1212 was mixed and apply with Belzona Super wrap installed afterwards.

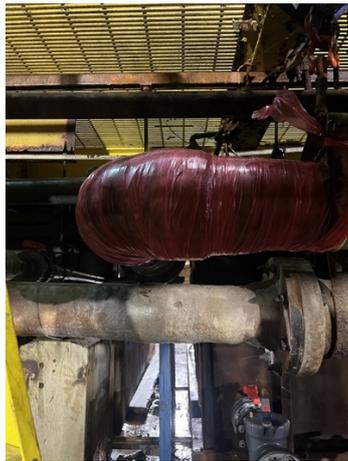
Newly installed Belzona Superwrap II

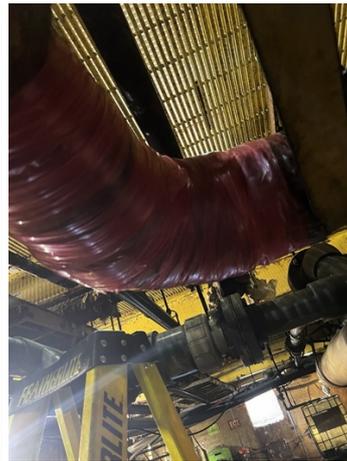
Belzona Super wrap installed successfully.

Belzona was not only able to seal the leak in a couple of minutes but also completed the whole installation and the equipment put back in service as stipulated in the product IFU. Follow up with customer confirmed that there was no leak or sipping as the Super wrap II successfully solve the issue.
