Motor Manufacturer Wash Bay

ID: 9497

Industry: General Industry
Application: TCC-Tanks and Chemical Containment Areas
Substrate: Carbon steel
Products: Belzona 5831LT

Customer Location: Derby
Application Date: September 2019

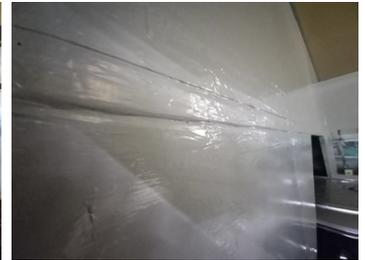
5 years on and the coating is still perfect. The client uses this as an example of their maintenance regime

Close up of the coating, 5 years later, in operation 24/7/365

Due to the location of the works, mechanical preparation could not be employed, making the whole project hand-prep only. This was carried out by up to 10 operatives, using scrapers and wire brushes.

Belzona 5831LT was applied at 2 coats according to IFU specifications.
