Application of Belzona on sea water strainer

Customer Location: Mina Abdallah, Kuwait

Products: Belzona 1311 (Ceramic R-Metal), Belzona 1321 (Ceramic S-Metal)

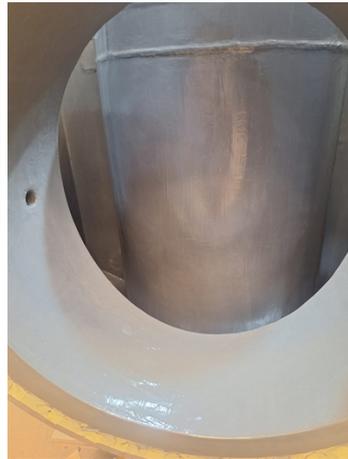
Basically the customer was facing severe corrosion issues, as the strainer was exposed to the sea water. Due the aggressive nature of the sea water, there would be a complete metal loss eventually leading to the leakage of the strainer.

Condition of the shell after exposing to the sea water

1. The entire strainer and cover was grit blasted to obtain near white metal finish.
2. After the grit blasting, the entire dust was removed the using compressor air blower, and degreased to remove the residue
3. Belzona 1311 was mixed & applied to smooth out the welding joints and projections.
4. Belzona 1321 was mixed applied as per the IFU.

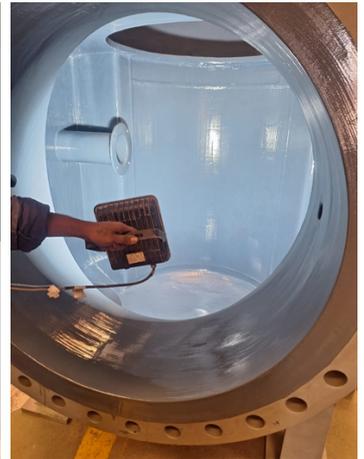
Condition of the shell cover after exposing to the sea water
