BELZONA SUPERWRAP II APPLICATION ON 24 inch ELBOWS

ID: 9501

Industry: Chemical & Petrochemical
Application: VPF-Valves, Pipes and Fittings
Substrate: Carbon steel
Products: Belzona 1111 (Super Metal), Belzona SuperWrap II

Customer Location: Mina Abdallah, Kuwait
Application Date: June 2023

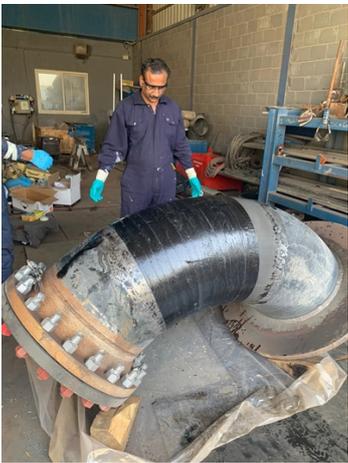
Trial/demo application of Belzona SuperWrap II as per the engineered design.

The Belzona SW II application was carried out in accordance with the design method statement. The elbows were grit blasted to achieve a near white metal finish. The substrate was cleaned and degreased before the application. Belzona 1111 was used to resurface and smooth the weld seams. SW II Belzona 1982 resin and Belzona 9381 245mm width reinforcement tape were applied in accordance with the design specifications."

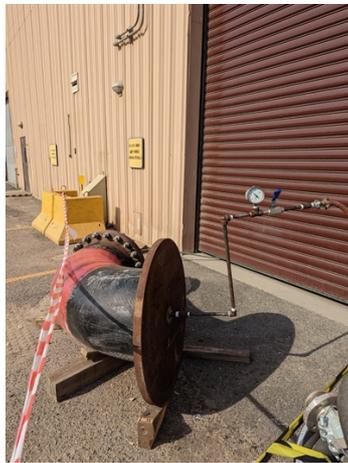
No trace of any leak or peel-off after the completed hydrotest.

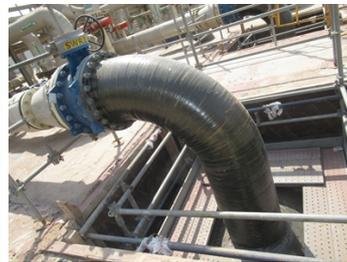
SuperWrap II application for 24-inch elbow of 3.6 m length.

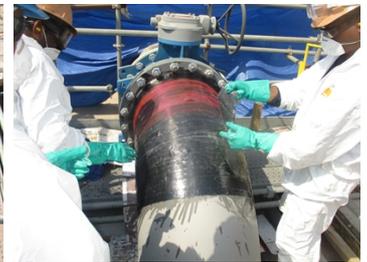
SuperWrap II application by distributor
