BELZONA SUPERWRAP II APPLICATION ON 24 inch ELBOWS

ID: 9501

Customer Location: Mina Abdallah, Kuwait
 Application Date: June 2023

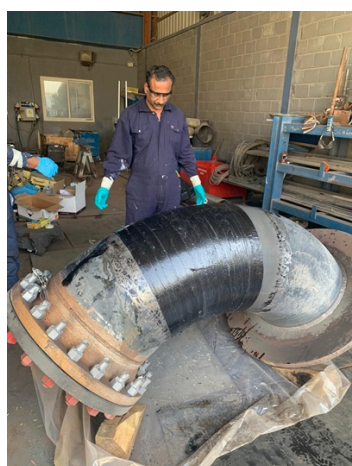
Trial/demo application of Belzona SuperWrap II as per the engineered design.

The Belzona SW II application was carried out in accordance with the design method statement. The elbows were grit blasted to achieve a near white metal finish. The substrate was cleaned and degreased before the application. Belzona 1111 was used to resurface and smooth the weld seams. SW II Belzona 1982 resin and Belzona 9381 245mm width reinforcement tape were applied in accordance with the design specifications."

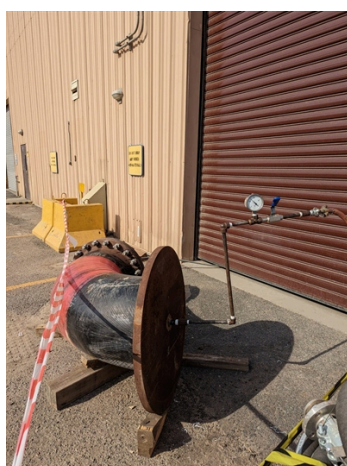
No trace of any leak or peel-off after the completed hydrotest.

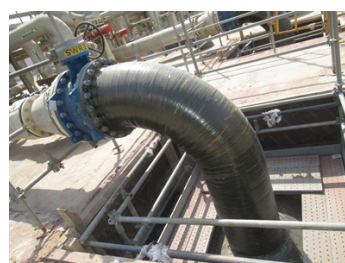
SuperWrap II application for 24-inch elbow of 3.6 m length.

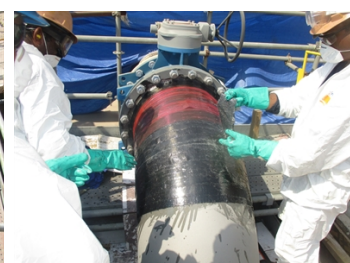
SuperWrap II application by distributor
