# Belzona Coating Protects Hopper Interior from Wear

ID: 9504

Industry: *Food & Drink*  
Application: *SHM-Solids Handling Machinery*

Substrate: *Carbon steel*  
Products: *Belzona 5821*

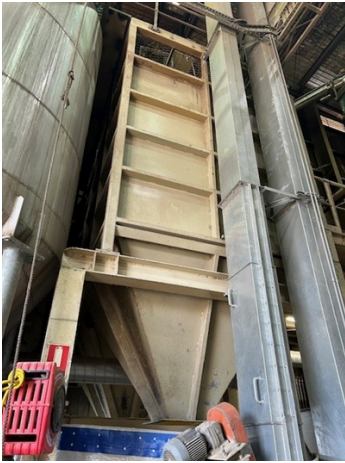
Hopper was approximately 2 storeys high.

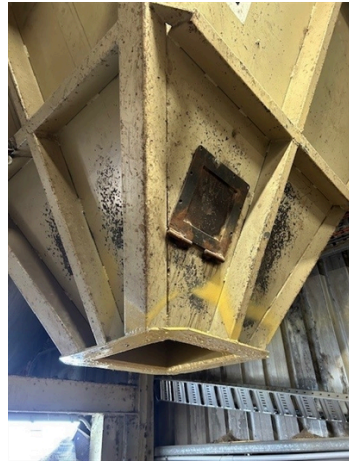
Tapered bottom end making bottom access difficult.

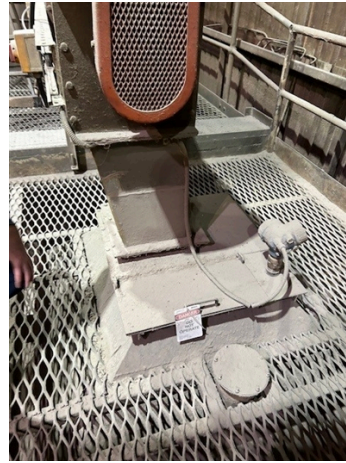
Access hatch from the top of the hopper allowing for one man entry.

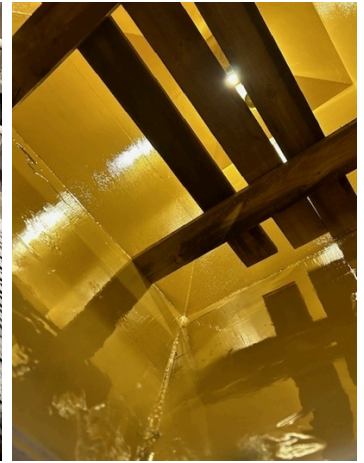
Platforms set up internally for applicators to stand on during the application process.

With clear access to all open sections of the hoppers, internal platforms were set up and ducting placed for all dust extraction from abrasive blasting to be carried out safely. Once this was done and ducting removed, the Belzona 5821 was spray applied in two separate coats achieving a total of 500 micron film thickness and allowed to cure for a full 5 days.
