Belzona Coating Protects Hopper Interior from Wear

ID: 9504

Industry: *Food & Drink*
Application: *SHM-Solids Handling Machinery*

Substrate: *Carbon steel*
Products: *Belzona 5821*

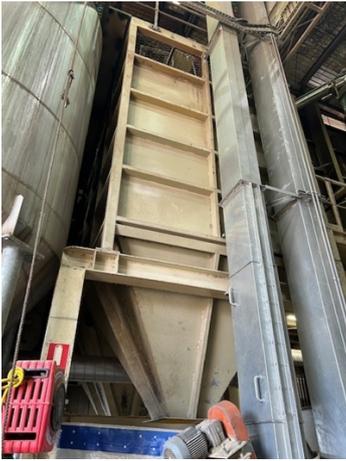
Hopper was approximately 2 storeys high.

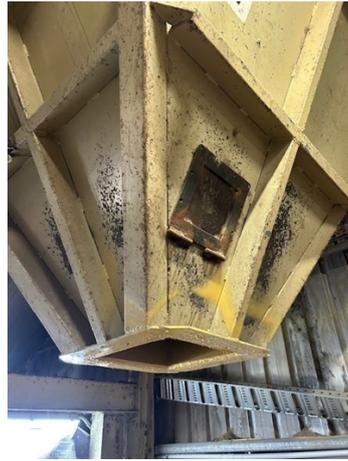
Tapered bottom end making bottom access difficult.

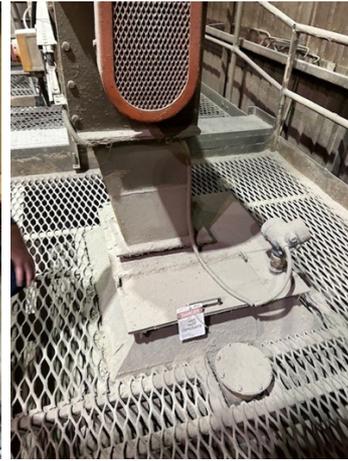
Access hatch from the top of the hopper allowing for one man entry.

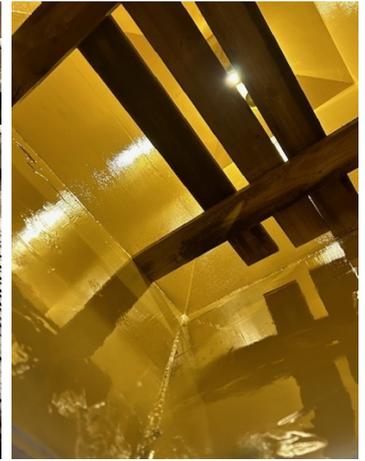
Platforms set up internally for applicators to stand on during the application process.

With clear access to all open sections of the hoppers, internal platforms were set up and ducting placed for all dust extraction from abrasive blasting to be carried out safely. Once this was done and ducting removed, the Belzona 5821 was spray applied in two separate coats achieving a total of 500 micron film thickness and allowed to cure for a full 5 days.
