Belzona creates solution for ongoing floor issues

ID: 9505

Customer Location: Mansfield
Application Date: August 2024

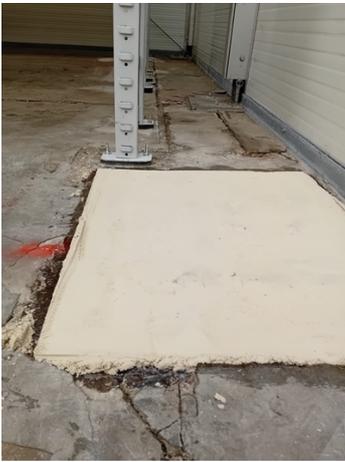
Uneven floor area made good using Belzona 4111 MagmaQuartz to support main racking stanchions

Whilst that was drying, the concrete areas were conditioned with Belzona 4911 TX Conditioner and Belzona 9411 release agent was applied to a wooden former for the Belzona 4111 pad for the racking.

The Belzona 4111 was mixed as per the IFU using a Daines Mixer and applied to the target area, compressing and smoothing it over with a finishing trowel. The same was done (without former) to the larger damaged area, this time using Belzona 4131.

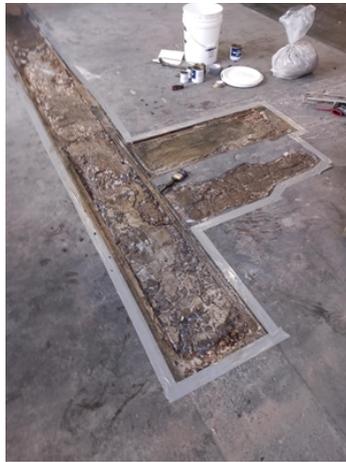
Damaged area prepared and conditioned with Belzona 4911 ready to accept Belzona 4131 MagmaScreed

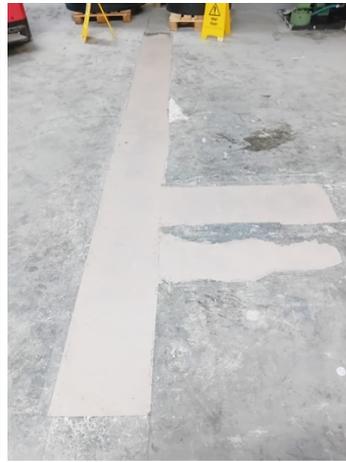
Damaged area fully repaired, screeded and feather edged with Belzona 4131 MagmaScreed to provide flat safe running surface for fork lift trucks and handling machinery

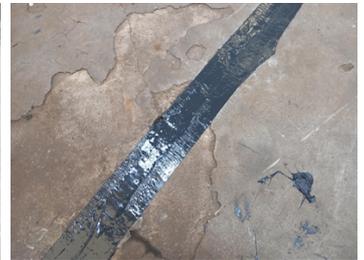
One of 5 expansion joints raked out, cleaned, conditioned with Belzona 2911 Conditioner and finished with Belzona 2211 Hi-Build elastomer

Expansion joint: 20mm backer rod was placed into the joint at a depth half that of the width and Belzona 2911 conditioner was

applied and allow to become touch dry.

The Expansion joint was then finished using Belzona 2211 to a masked area using applicators to create a smooth finish and removing the masking tape immediately
