Belzona creates solution for ongoing floor issues

ID: 9505

Industry: General Industry
Application: FPA-Floor Problem Areas
Substrate: Concrete
Products: Belzona 2211 (MP Hi-Build Elastomer), Belzona 2911 (Elastomer QD Conditioner), Belzona 4111 (Magma-Quartz), Belzona 4131 (Magma-Screed), Belzona 4911 (Magma TX Conditioner), Belzona 9411 (Release Agent)

Customer Location: Mansfield
Application Date: August 2024

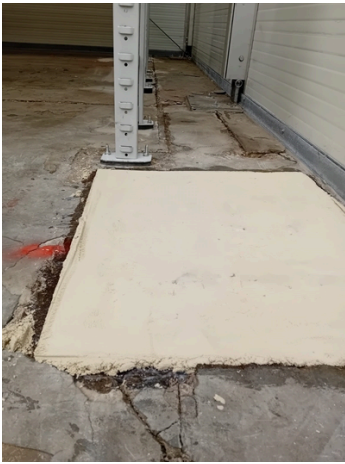
Uneven floor area made good using Belzona 4111 MagmaQuartz to support main racking stanchions

Whilst that was drying, the concrete areas were conditioned with Belzona 4911 TX Conditioner and Belzona 9411 release agent was applied to a wooden former for the Belzona 4111 pad for the racking.

The Belzona 4111 was mixed as per the IFU using a Daines Mixer and applied to the target area, compressing and smoothing it over with a finishing trowel. The same was done (without former) to the larger damaged area, this time using Belzona 4131.

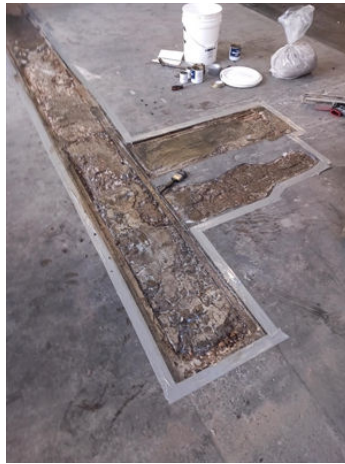
Damaged area prepared and conditioned with Belzona 4911 ready to accept Belzona 4131 MagmaScreed

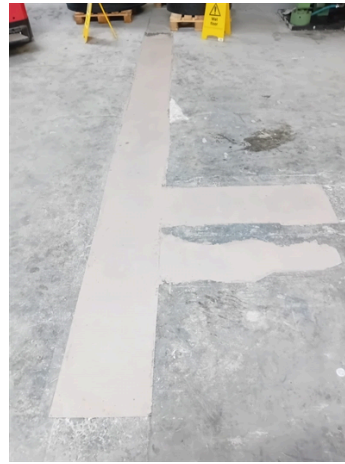
Damaged area fully repaired, screeded and feather edged with Belzona 4131 MagmaScreed to provide flat safe running surface for fork lift trucks and handling machinery

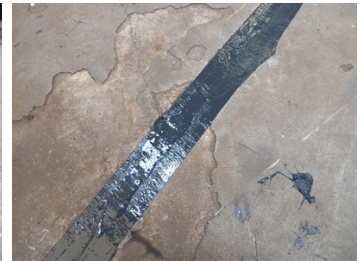
One of 5 expansion joints raked out, cleaned, conditioned with Belzona 2911 Conditioner and finished with Belzona 2211 Hi-Build elastomer

Expansion joint: 20mm backer rod was placed into the joint at a depth half that of the width and Belzona 2911 conditioner was

applied and allow to become touch dry.

The Expansion joint was then finished using Belzona 2211 to a masked area using applicators to create a smooth finish and removing the masking tape immediately
