Corroded End Tubes Updated

ID: 9511

Application: HEX-Heat Exchangers

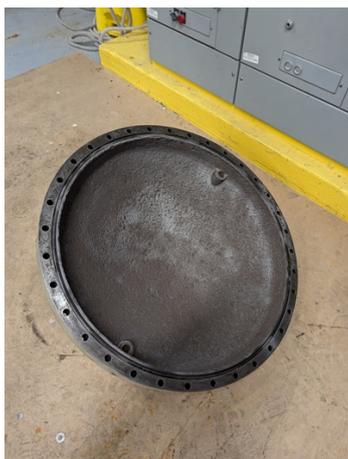
The chiller's end tubes were suffering from significant corrosion, with visible pitting and metal loss.

End tubes before product application

The substrate was grit blasted and properly cleaned. Belzona 1121 was used for filling and resurfacing the pits and metal loss. Then, two coats of Belzona 1321 were applied.

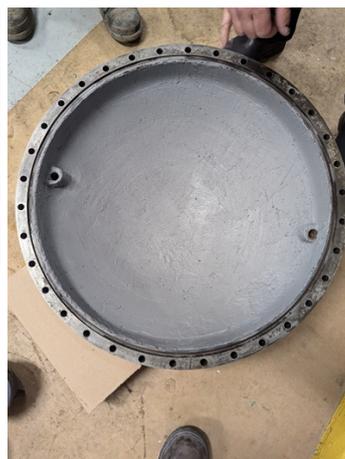
Metal resurfacing completed

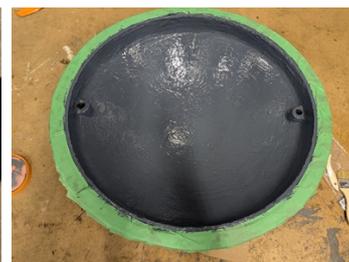
Belzona 1321 coating applied
