# Corroded End Tubes Updated

ID: 9511

Application: HEX-Heat Exchangers

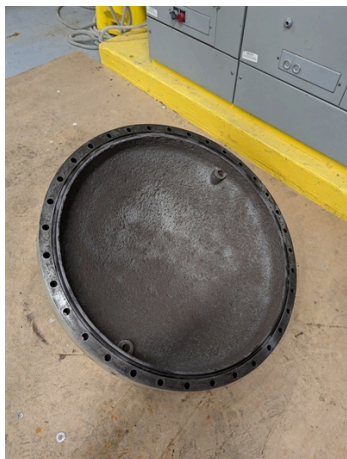
The chiller's end tubes were suffering from significant corrosion, with visible pitting and metal loss.

End tubes before product application

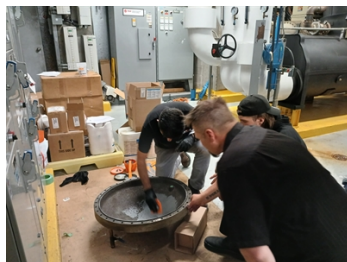
Metal resurfacing with Belzona 1121

The substrate was grit blasted and properly cleaned. Belzona 1121 was used for filling and resurfacing the pits and metal loss. Then, two coats of Belzona 1321 were applied.

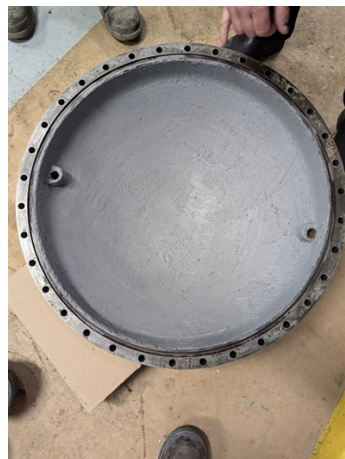
Metal resurfacing completed

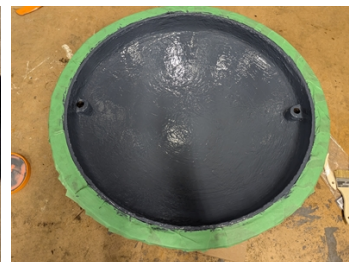
Belzona 1321 coating applied
