Firewater Bilge Pump Rebuild and Protective Coating for Marine Vessel

Industry: Marine
Application: CEP-Centrifugal Pumps
Substrate: Carbon steel
Products: Belzona 1111 (Super Metal), Belzona 1341 (Supermetalglide)

Customer Location: Houston, TX
Application Date: July 2024

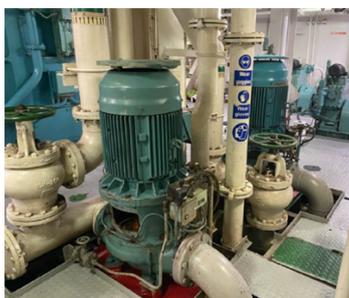
External photo of the Fire and Bilge Pump in Service

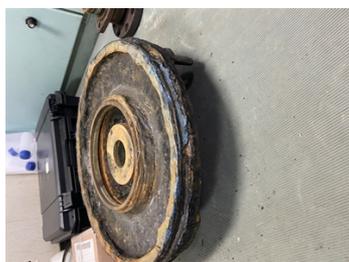
The client had a critical firewater bilge pump that was leaking because corrosion damage. They were in the Houston TX area resupplying at local chemical facilities before they could return on their voyage across the sea. They needed a quick repair to rebuild the pump internals, provide a protective coating, and stop the leak within a short amount of time so they could continue on.

Center plate condition before the application.

1. Vapor Blasting (SSPC-SP10) 3mil profile.
2. Rebuild Pump Internals using Belzona 1111
4. Coat the Asset with Belzona 1341

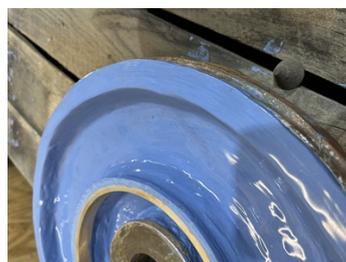
Application completed with Belzona 1341.

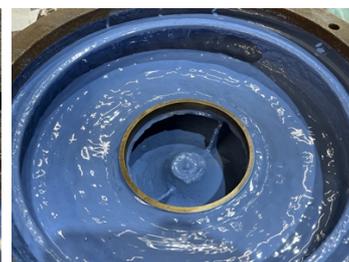
Application completed with Belzona 1341.
