Belzona Expansion Joint Solution at Hospital

ID: 9516

Industry: Buildings & Structures
Application: FPA-Floor Problem Areas
Substrate: Concrete
Products: Belzona 2211 (MP Hi-Build Elastomer), Belzona 2911 (Elastomer QD Conditioner), Belzona 4231 (E Magma-Quartz), Belzona 5231 (SG Laminate)

Customer Location: Murfreesboro, TN
Application Date: October 2023

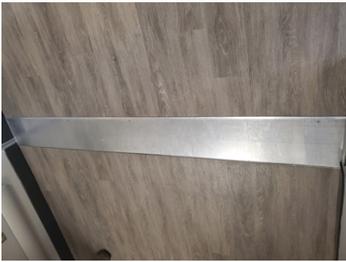
Customer had metal plate over expansion joint that was a trip hazard as well as being uncomfortable for patients to cross on a hospital bed.

Metal plate was installed when hospital was renovated and was a trip hazard.

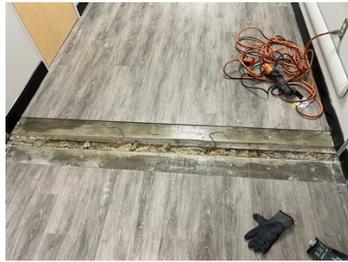
Plate Removed area was cleaned and backer rod was added.

Joint was rebuilt with Belzona 4131, Belzona 2211 was used to form the joint and Belzona 2911 conditioner was used as a primer.

The Metal plate was removed, and joint was cleaned out. Edges of the concrete was rebuilt with Belzona 4131. Backer rod was inserted in the void area and Belzona 2211 was used to form the joint. Belzona 5231 was used as the topcoat to meet up with the existing floor.

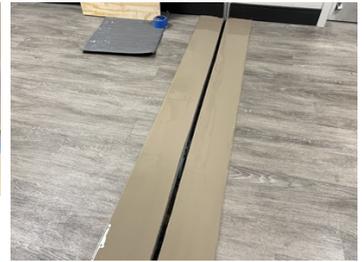
Belzona 5231 was used as the topcoat.
