Belzona Expansion Joint Solution at Hospital

ID: 9516

Industry: Buildings & Structures
Application: FPA-Floor Problem Areas
Substrate: Concrete
Products: Belzona 2211 (MP Hi-Build Elastomer), Belzona 2911 (Elastomer QD Conditioner), Belzona 4231 (E Magma-Quartz), Belzona 5231 (SG Laminate)

Customer Location: Murfreesboro, TN
Application Date: October 2023

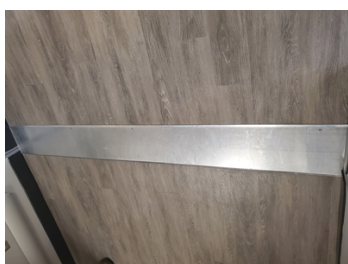
Customer had metal plate over expansion joint that was a trip hazard as well as being uncomfortable for patients to cross on a hospital bed.

Metal plate was installed when hospital was renovated and was a trip hazard.

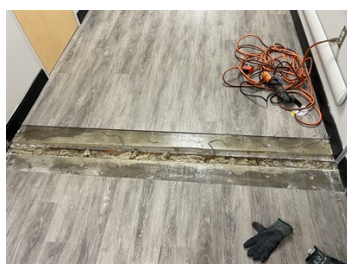
Plate Removed area was cleaned and backer rod was added.

The Metal plate was removed, and joint was cleaned out. Edges of the concrete was rebuilt with Belzona 4131. Backer rod was inserted in the void area and Belzona 2211 was used to form the joint. Belzona 5231 was used as the topcoat to meet up with the existing floor.

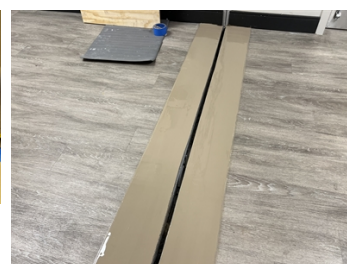
Joint was rebuilt with Belzona 4131, Belzona 2211 was used to form the joint and Belzona 2911 conditioner was used as a primer.

Belzona 5231 was used as the topcoat.
