Belzona floor repair

Application: *FPA-Floor Problem Areas*

Substrate: *Concrete*

Products: *Belzona 4111 (Magma-Quartz), Belzona 5811 (Immersion Grade)*

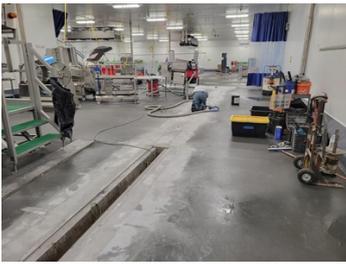
The floor was prepped with hand tools, cleaned and then repaired whit Belzona 4111.

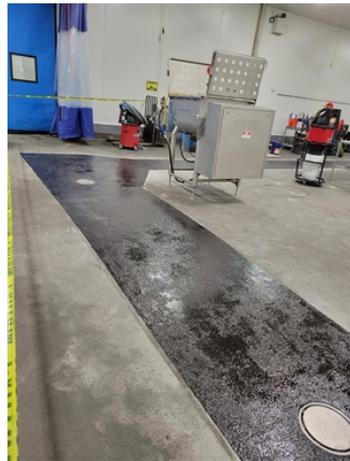
First coat of Belzona 5811 black on floor for protection

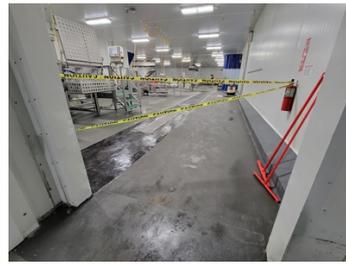
Second and final coat of Belzona 5811

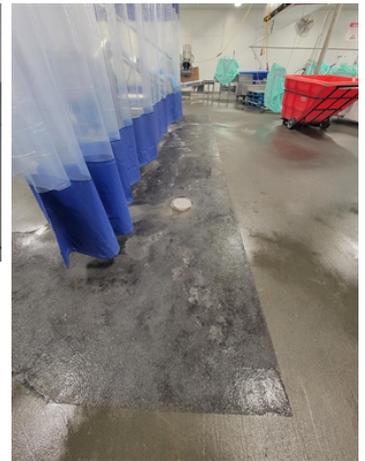
The floor 2 weeks after Application
