Belzona Solution for Contact Coolers

ID: 9519

Industry: *Marine*
Application: *SOS-Ships and Offshore Structures*

Substrate: *Carbon steel*
Products: *Belzona 1121 (Super XL-Metal), Belzona 5821*

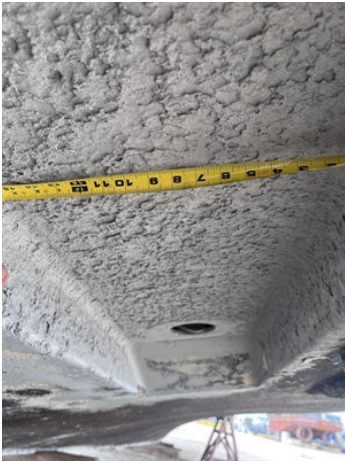
Customer was seeing significant erosion under contact cooler on bottom of boat.

Before Application

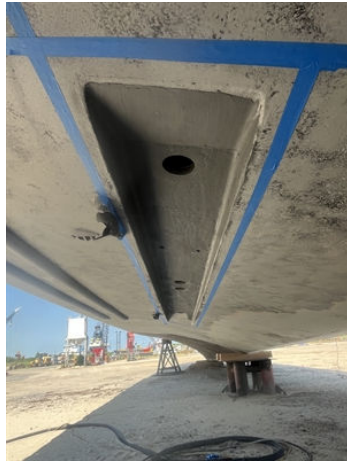
Application of Belzona 1121

Pit filling with Belzona 1121 and overcoat with Belzona 5821 to provide corrosion resistance.

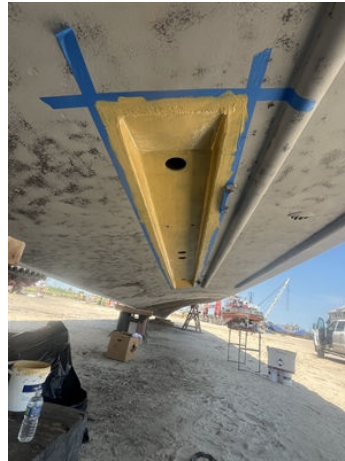
Application of 1st coat of
Belzona 5821 in yellow

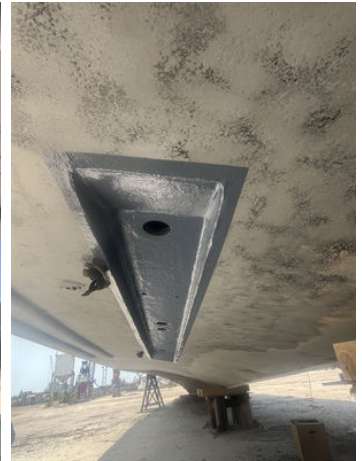
Application of 2nd coat of
Belzona 5821 in grey
