# Belzona Solution for Contact Coolers

ID: 9519

Industry: *Marine*  
Application: *SOS-Ships and Offshore Structures*

Customer Location: *Gibson, Louisiana*  
Application Date: *May 2024*

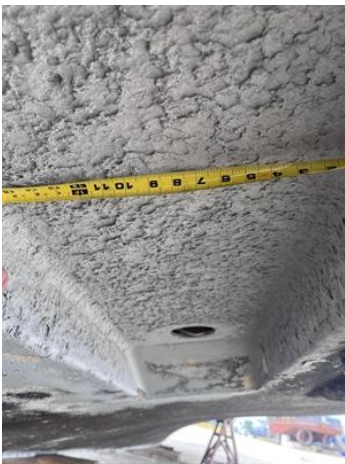
*Customer was seeing significant erosion under contact cooler on bottom of boat.*

Before Application
