# BELZONA REPAIRS MEG TANK HOLED BY CUI

Customer Location: Oil Major St Fergus Gas plant, Scotland  
Application Date: May 2006

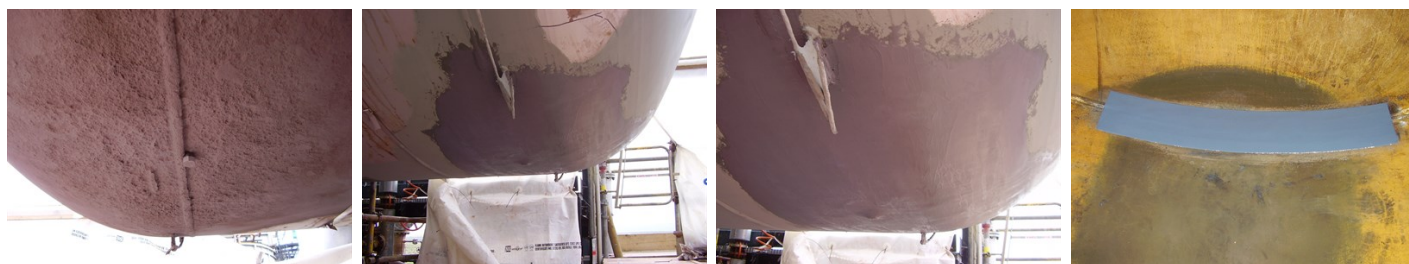
Corrosion Under Insulation (CUI) on the vessel had caused a pin hole in the vessel wall

- \* CUI with pinhole drilled, threaded and bolted ,
- \* Application of Belzona® 1111 ,
- \* Completion of the Application of the Belzona® 1111 externally ,
- \* Application of Belzona® 1111 & 1321 internally over the bolt ,

Hot work was not allowed on site without a major shut down. Belzona sealed leak and provided protection to surrounding area to prevent future problems of CUI.
