Water Plant Sedimentation Tank

ID: 9520

Application: TCC-Tanks and Chemical Containment Areas

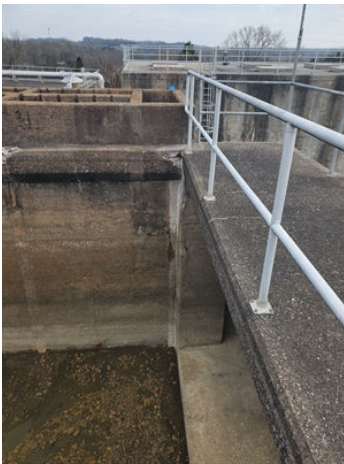
Tan was suffering damage from age as well as a couple of very cold winters that caused the tank to crack and one corner to separate. The customer was losing a lot of water.

Separating Wall Corner

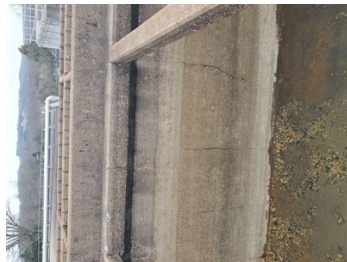
Cracks in wall.

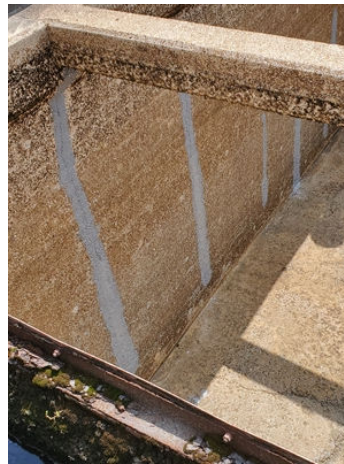
Repair with Belzona 3121

Tank was pressured washed and set a day to dry then primer was applied to the area for the concrete rebuild. Belzona 3121 and cloth was used on the cracks on the side and the bottom of the tank Then one coat of Belzona 5811 was sprayed and Belzona 5812 DW was sprayed in the proper overcoat window.

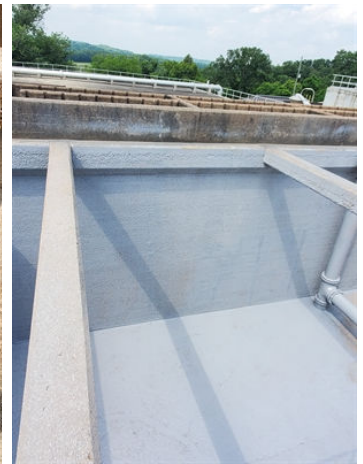
Final application with Belzona 5812DW
