Water Plant Sedimentation Tank

ID: 9520

Application: TCC-Tanks and Chemical Containment Areas

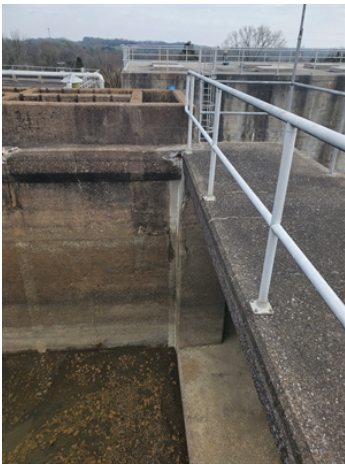
Tan was suffering damage from age as well as a couple of very cold winters that caused the tank to crack and one corner to separate. The customer was losing a lot of water.

Separating Wall Corner

Tank was pressure washed and set a day to dry then primer was applied to the area for the concrete rebuild. Belzona 3121 and cloth was used on the cracks on the side and the bottom of the tank. Then one coat of Belzona 5811 was sprayed and Belzona 5812 DW was sprayed in the proper overcoat window.

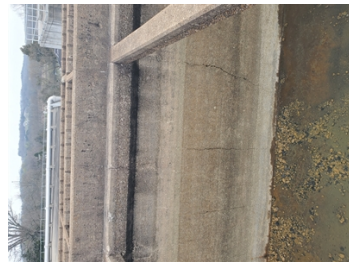
Cracks in wall.

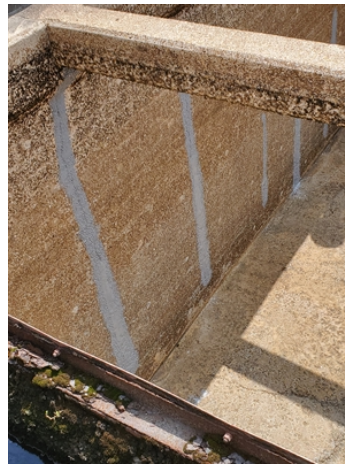
Repair with Belzona 3121

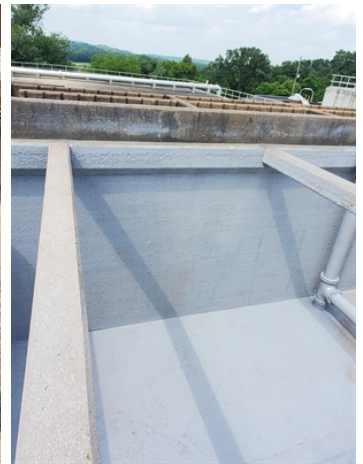
Final application with Belzona 5812DW
