Belzona Seals Leaking SF6 Flange

ID: 9521

Customer Location: London
Application Date: May 2024

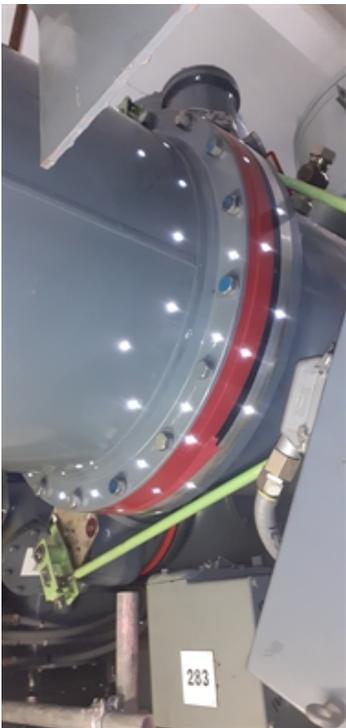
SF6 leaking from multiple location around pipe joint. Client covered joint with tape to stem leak.

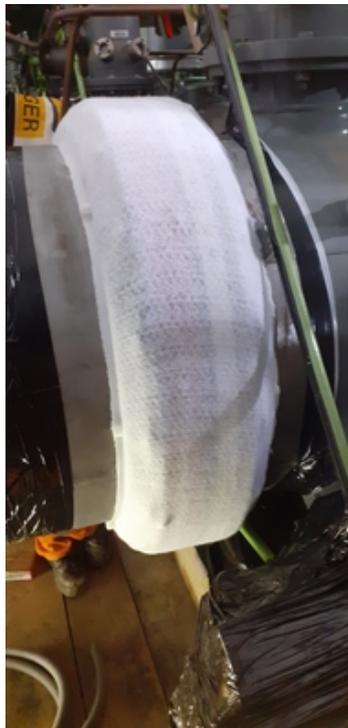
Repair area substrate prepared utilising bristle blaster and breather membrane installed.

The application area was prepared using MBX (Bristle Blaster). Stainless steel wheels were used as the substrate was aluminium. Substrate was degreased using Belzona 9111 to remove any contaminants.

Breather membrane was installed tightly to the profile of the flange due to restricted access from near-by components. Breather pipe was allowed to protrude through membrane.

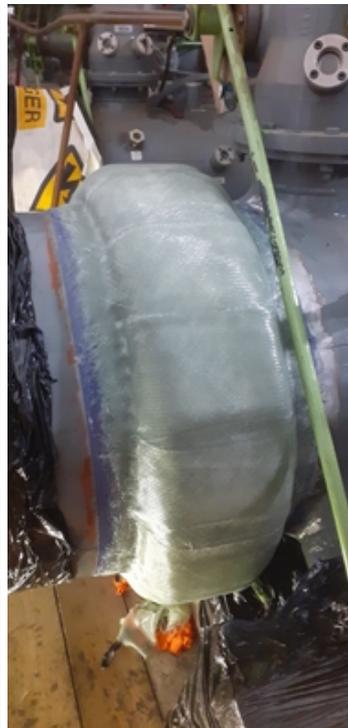
Belzona 7311 applied to repair area incorporating Belzona 9341. 5x layers of Belzona 9371 using Belzona 1981 resin for wetting.

A combination of Belzona 7311 and 9341 along with Belzona 1981 and Belzona 9371 were used to encapsulate the full circumference of the flange.

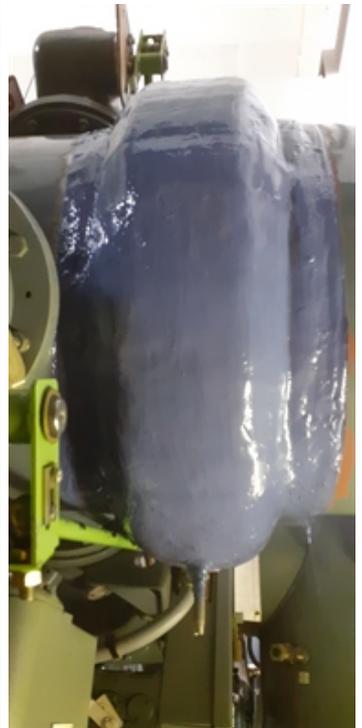
SF6-FIX leak sealing repair completed, with vent pipe left open at 6 o'clock position until full cure is achieved. Vent pipe is capped off following full cure.

Breather pipe and 3D printed base plate were installed at 6 o'clock position as SF6 is heavier than air.

The breather pipe was left to vent until all materials used in the repair had achieved full cure. The vent pipe was then capped off and the system repressurised.
