Pipeline Cold Bonding Application with Belzona 1111

ID: 9523

Application: VPF-Valves, Pipes and Fittings

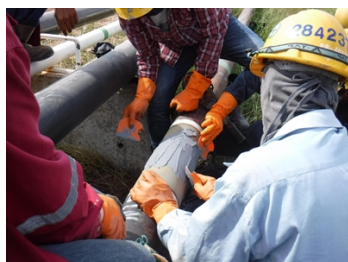
The client runs high pressure water through different diameter pipelines to inject into oil wells, these pipelines were welded together. Upon inspection, the joints showed evidence of thin wall defects where the weld material was corroding from the inside of the pipeline - a form of galvanic corrosion resulting from the weld joint filler being less noble than the pipe material.

Various Pipeline Diameters and Geometries

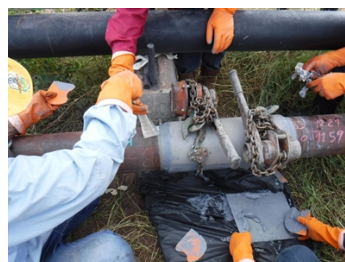
Wetting out substrate with Belzona 1111 after Surface Prep and Solvent Cleaning

1. The repair area and two plates were blasted using garnet to be achieve ISO SA2.5 cleanliness and a minimum surface profile of 75 microns.
2. All prepared surfaces were cleaned with a suitable degreaser before inspection and measurement of the climatic conditions.
3. Welding rod was cut to small pieces and used as shims to provide a uniform bond thickness.
4. Belzona 1111 was mixed thoroughly and used to wet out the repair area and plates using a short bristled brush.
5. Belzona 1111 was applied to the plates which were then adjusted to the correct position and clamped using a hoist and chain to remove air.
6. The Belzona product was left to cure as per the IFU.
