Belzona repairs transformer cooling fins

Industry: Power
Application: TCC-Tanks and Chemical Containment Areas
Substrate: Carbon steel
Products: Belzona 1161 (Super UW-Metal), Belzona 5831 (ST-Barrier)

Customer Location: Scotland
Application Date: May 2017

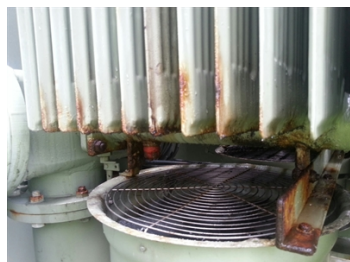
Transformer cooling fins had become corroded from water collecting on the fins edges & started to leak

Corroded sections

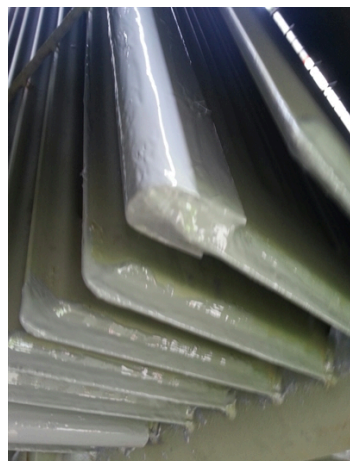
Belzona 1161 plate bond

Welding was not possible due to the oil in the fins. By using a cold applied system repairs could be undertaken promptly & safely

The fins were prepared using Dremel type tools & small grinders. 'U' shaped doubler plates were then bonded using Belzona 1161 UW Metal on the most corroded fins. All areas were then overcoated using Belzona 5831 to provide corrosion protection.

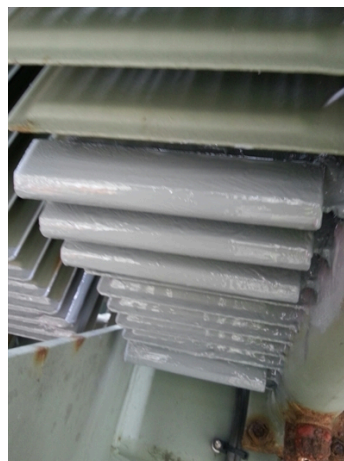
Repaired section

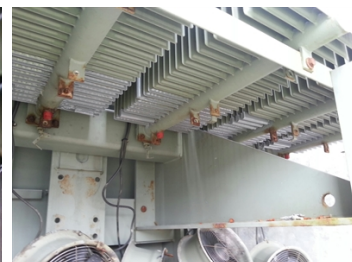
Areas overcoated with Belzona 5831
