# Belzona repairs transformer cooling fins

ID: 9524

Industry: Power

Application Date: May 2017

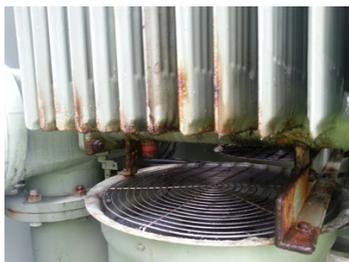
Transformer cooling fins had become corroded from water collecting on the fins edges & started to leak

Corroded sections

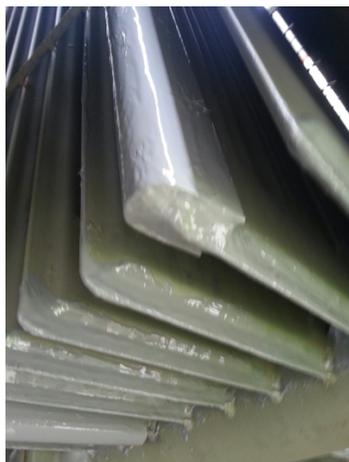
Belzona 1161 plate bond

The fins were prepared using Dremel type tools & small grinders. 'U' shaped doubler plates were then bonded using Belzona 1161 UW Metal on the most corroded fins. All areas were then overcoated using Belzona 5831 to provide corrosion protection.

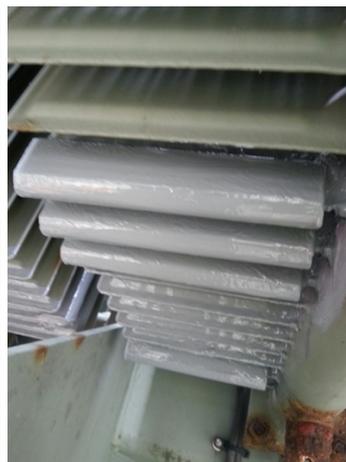
Repaired section

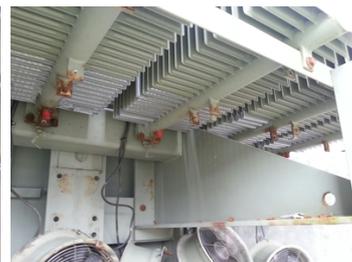
Areas overcoated with Belzona 5831
