Belzona repairs transformer cooling fins

ID: 9524

Industry: Power

Application: TCC-Tanks and Chemical Containment Areas

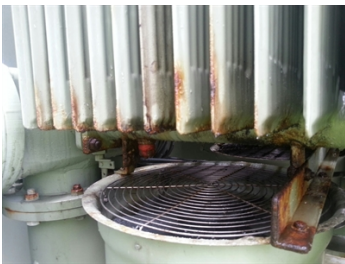
Transformer cooling fins had become corroded from water collecting on the fins edges & started to leak

Corroded sections

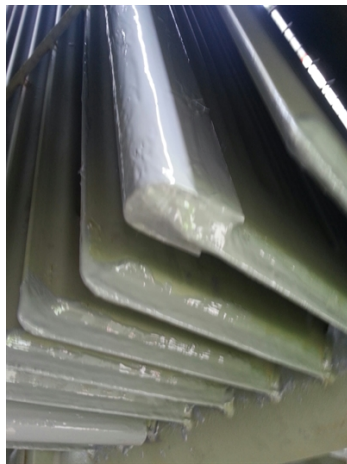
Belzona 1161 plate bond

The fins were prepared using Dremel type tools & small grinders. 'U' shaped doubler plates were then bonded using Belzona 1161 UW Metal on the most corroded fins. All areas were then overcoated using Belzona 5831 to provide corrosion protection.

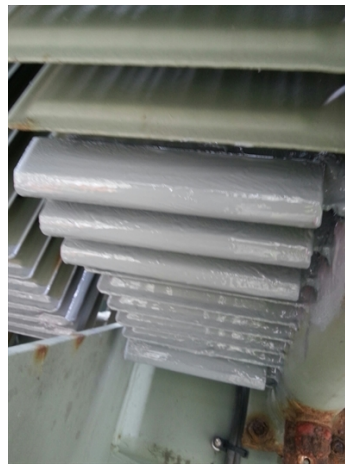
Repaired section

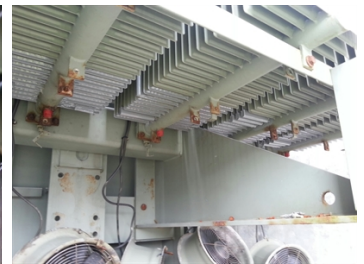
Areas overcoated with Belzona 5831
