Tank base seal on oil storage tank

ID: 9525

Industry: Oil & Gas
Application: GSS-Gaskets, Seals and Shims
Substrate: Carbon steel
Products: Belzona 3131 (WG Membrane), Belzona 3921 (GSC Surface Conditioner), Belzona 6111 (Liquid Anode)

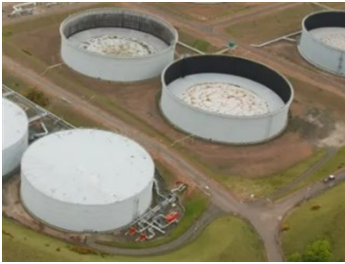
A large diameter oil storage tank had a seal around the annular rim. Movement & exposure to the elements had degraded this existing seal to the point where it not longer provided any protection from water ingressing underneath the tank.

Tank farm

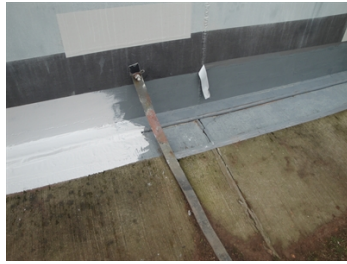
Belzona 3921 applied & 1st coat of Belzona 3131

The full tank circumference was grit blasted to SA2.5 & 75 microns in a 600mm band from tank wall to concrete base. Two coats of Belzona 6111 were first applied, then Belzona 3921. Following the recommended tank base sealing system bridging tape & foam backer rod were used to extend the bond line over the void between rim & concrete base. Belzona 9311 was then applied with Belzona 3131 to complete the system.

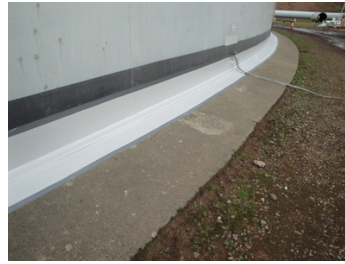
1st coat of Belzona 3131

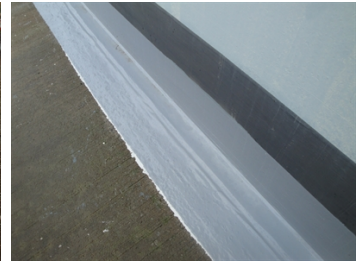
Completed application

Using this system provides long term protection. The flexibility of the Belzona membrane means it can cope with the movement of the tank as the fluid level inside rises & falls. The ability of the Belzona system to bond seamlessly to metal & concrete is key in this application.
