Belzona 1111 Solves Hairline Crack in Fiberglass Tank

ID: 9526

Customer Location: Jasper, AL
Application Date: August 2024

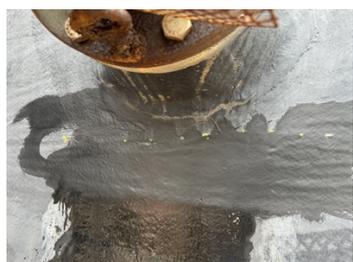
This refinery has 18 year old fiberglass holding tanks that have been in use. A hairline crack formed underneath the flange and a fluid had begun to weep out causing a loss.

Before: Yellow Dots mark the crack, we cleaned the area with Acetone

First, we cleaned the fiberglass and fluid up using Acetone after the fluid level was dropped below the crack. We proceeded to use a flapper disk attached to a grinder to get a good profile on the fiberglass (hairy fibers). We proceeded to tape the area using duct tape while simultaneously measuring the amount of reinforcement cloth needed. Once prepared, we engrained 9341 on the board with 1111, first painted a layer of 1111 on the tank, and then placing the strips of cloth into the 1111, finishing by encapsulating a final layer of 1111.

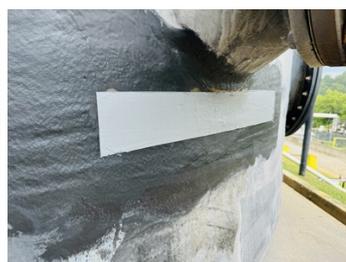
After: We applied 1 coat of Belzona 1111 with Reinforcement Cloth Engrained.

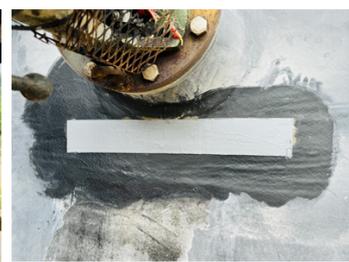
Finalized application.
