# Belzona materials repair, protect and improve severely damaged diffuser for pump station

ID: 9528

Industry: Water / Wastewater  
Application: CEP-Centrifugal Pumps  
Substrate: Cast Iron  
Products: Belzona 1111 (Super Metal), Belzona 1982 (SuperWrap II), Belzona 2141 (ACR-Fluid Elastomer), Belzona 2941 (Elastomer SP-Conditioner), Accessories

Customer Location: Longview, WA  
Application Date: December 2022

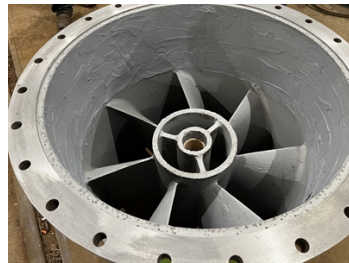
Following the decision to rebuild a pump station for mechanical wear issues, it was unexpectedly discovered that there was severe cavitation damage had occurred to the diffuser housing to the point that was expected to be unrepairable as the metal loss was so extreme that there were through wall holes around the entire perimeter.

Initial Damage

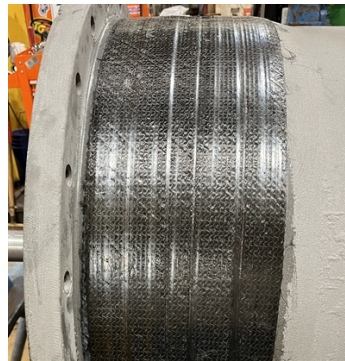
Metal loss rebuilt with Belzona 1111 Super Metal

A modified version of system leaflet CEP\_1 was used to rebuild the metal loss utilizing Belzona 1111 Super Metal. The exterior of the diffuser was reinforced using the Belzona Superwrap II carbon fiber wrap system. Finally two coats of Belzona 2141 ACR fluid were applied to the interior to protect against the devastating effects of cavitation.
