# Belzona materials repair, protect and improve severely damaged diffuser for pump station

ID: 9528

Industry: Water / Wastewater  
Application: CEP-Centrifugal Pumps  
Substrate: Cast Iron  
Products: Belzona 1111 (Super Metal), Belzona 1982 (SuperWrap II), Belzona 2141 (ACR-Fluid Elastomer), Belzona 2941 (Elastomer SP-Conditioner), Accessories

Customer Location: Longview, WA  
Application Date: December 2022

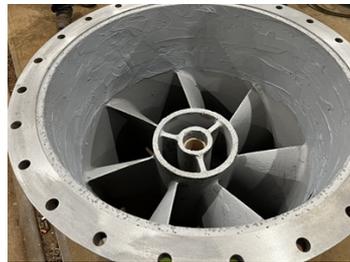
Following the decision to rebuild a pump station for mechanical wear issues, it was unexpectedly discovered that there was severe cavitation damage had occurred to the diffuser housing to the point that was expected to be unrepairable as the metal loss was so extreme that there were through wall holes around the entire perimeter.

Initial Damage

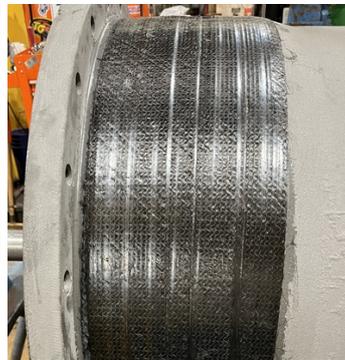
Metal loss rebuilt with Belzona 1111 Super Metal

A modified version of system leaflet CEP\_1 was used to rebuild the metal loss utilizing Belzona 1111 Super Metal. The exterior of the diffuser was reinforced using the Belzona Superwrap II carbon fiber wrap system. Finally two coats of Belzona 2141 ACR fluid were applied to the interior to protect against the devastating effects of cavitation.

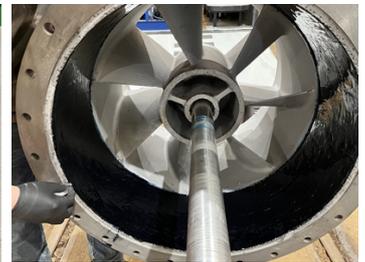
Exterior of diffuser reinforced with Belzona Superwrap II System
