# Belzona 1818 screw coating on heating plant

ID: 9529

Industry: Heating, Ventilation & Air Conditioning  
Application: SHM-Solids Handling Machinery

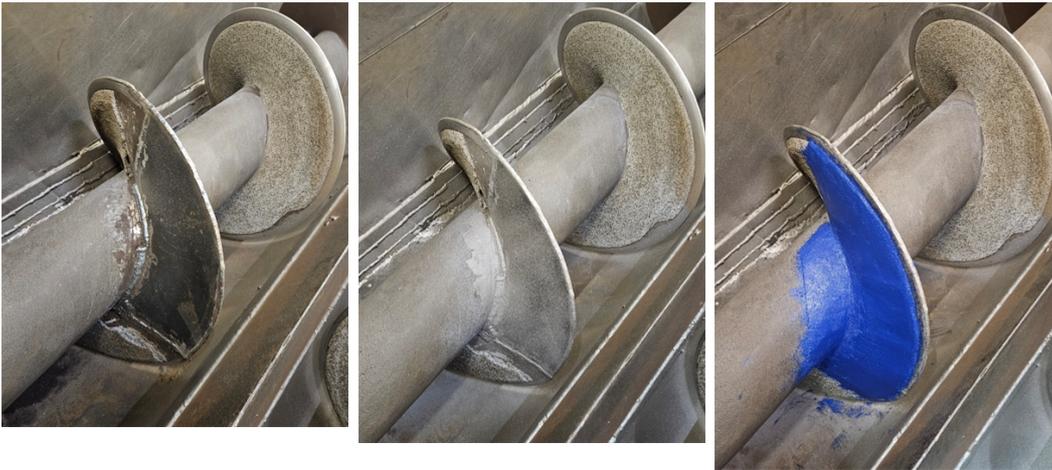
After a breakdown, the customer needed to repair the screws with a fast curing material, very close to start-up. The repair was carried out during the day and they were ready for start-up the same evening. A very successful quick-return-to-service repair.

The damage before grit blasting    The damage after grit blasting    The damage after coating with Belzona 1818

Clean surfaces before grit blasting, wash with Belzona 9111. Grit blast to SA 2.5 of the surfaces. Mix and apply Belzona 1818 using the supplied accessories
