# Belzona 1818 screw coating on heating plant

ID: 9529

Application: SHM-Solids Handling Machinery

Application Date: August 2024

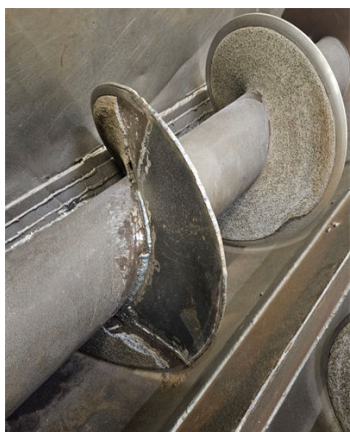
The damage before grit blasting

Clean surfaces before grit blasting, wash with Belzona 9111. Grit blast to SA 2.5 of the surfaces. Mix and apply Belzona 1818 using the supplied accessories

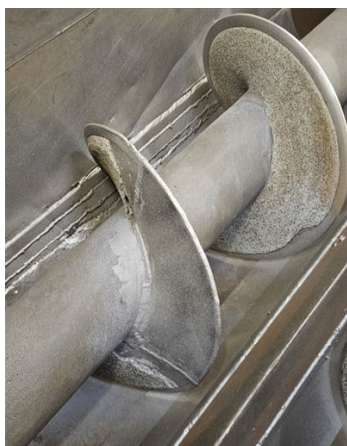
The damage after grit blasting

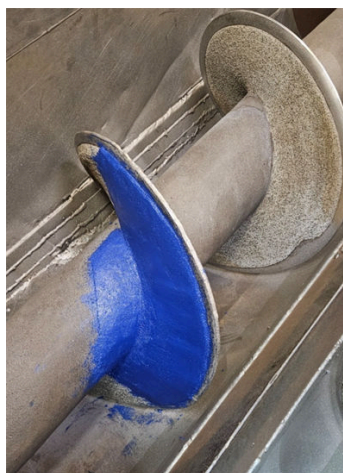
The damage after coating with Belzona 1818
