Belzona slows down mold and mildew issue for local Council

ID: 9530

Industry: Buildings & Structures

Products: Belzona 5122 (Clear Cladding Concentrate)

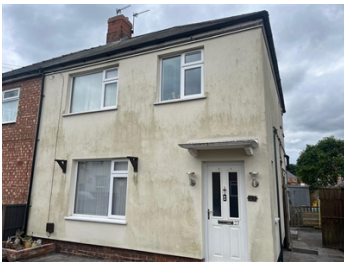
An issue was identified whereby the build up and growth of mold and mildew to shaded elevations needed to be stopped or slowed down. Belzona was approached to supply a solution to alleviate the build up of mold and mildew by effectively preventing the rendered environment from absorbing moisture

Rendered property suffering a build up of mold and mildew

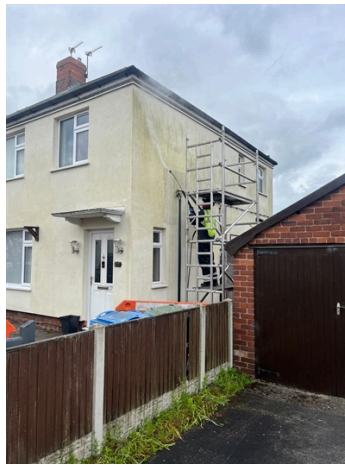
Preparation: Washing down the rendered walls with HP water & fungicidal wash prior to fixing any cracks or damaged rendered surfaces

All target surfaces were cleaned using HP water jetting at around 1,500psi

A fungicidal wash was incorporated to help destroy the existing mold and mildew

Any defects to the render were repaired and repointed using traditional methods in line with Belzona 5122 Instructions for use

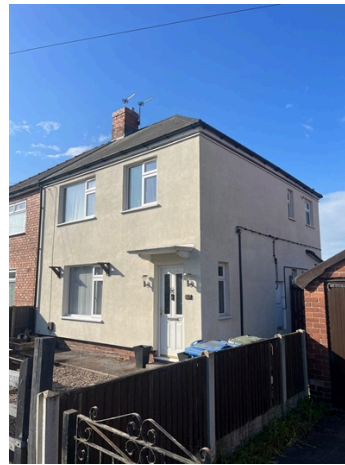
The property after the application of the Belzona 5122, appearing completely invisible

Belzona 5122 was mixed at a 9:1 ratio with clean water. 9 parts clean water to 1 part Belzona 5122

This was applied to the walls using a low pressure back-pack spray until all target surfaces were coated

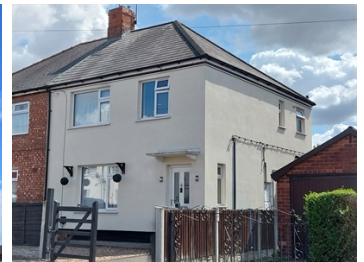
A full year on, Belzona has protected the render from moss, lichen, mildew and mold growth by restricting moisture absorption through every season.

There has been no sign of the return of mold or mildew a year later, and since the trial went ahead, a further 13 properties have been listed for the same application, leading to 180 assets eventually being treated over the next 18 months. a year later, the 5122 has prevented all mold growth.
