Belzona slows down mold and mildew issue for local Council

Industry: *Buildings & Structures*
 Application: *WPA-Wall Problem Areas*
 Substrate: *Other*
 Products: *Belzona 5122 (Clear Cladding Concentrate)*

Customer Location: *Retford*
 Application Date: *March 2024*

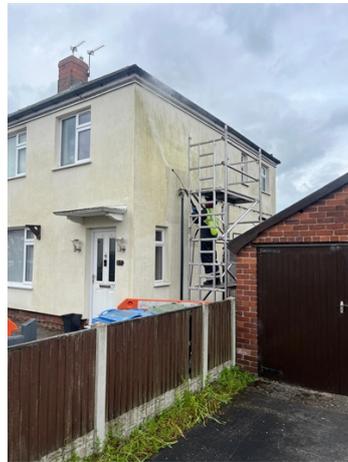
Rendered property suffering a build up of mold and mildew

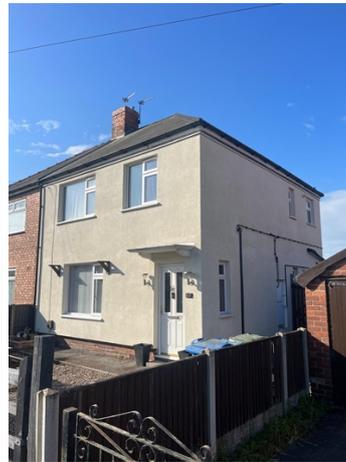
Preparation: Washing down the rendered walls with HP water & fungicidal wash prior to fixing any cracks or damaged rendered surfaces

All target surfaces were cleaned using HP water jetting at around 1,500psi

A fungicidal wash was incorporated to help destroy the existing mold and mildew

Any defects to the render were repaired and repointed using traditional methods in line with Belzona 5122 Instructions for use

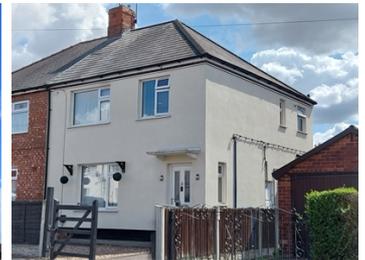
The property after the application of the Belzona 5122, appearing completely invisible

A full year on, Belzona has protected the render from moss, lichen, mildew and mold growth by restricting moisture absorption through every season.

Belzona 5122 was mixed at a 9:1 ratio with clean water. 9 parts clean water to 1 part Belzona 5122

This was applied to the walls using a low pressure back-pack spray until all target surfaces were coated
