Belzona Seals and Protects Corrugated Metal Roof Of a Waste Digester Chamber

Application: TCC-Tanks and Chemical Containment Areas

Substrate: Carbon steel

Products: Belzona 1161 (Super UW-Metal), Belzona 5831 (ST-Barrier)

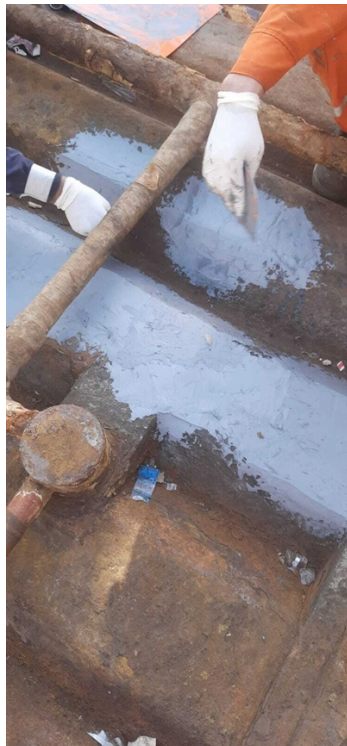
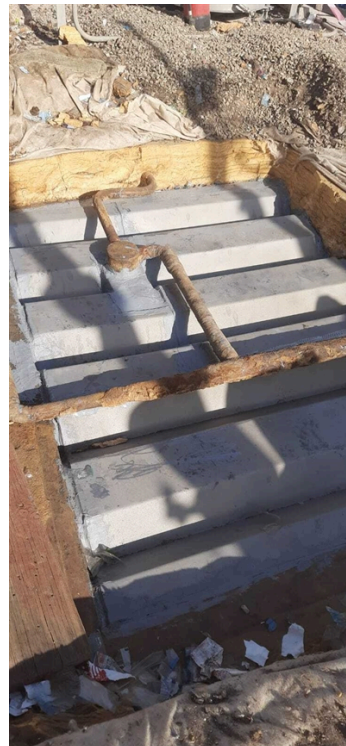
Situation before application

The corrugated roof suffered from multiple through holes created by severe corrosion. The content of the digester tank was methane gas, and mechanical surface preparation was undesirable due to the flammability of the content.

The existing corrugated roof had corrosion damaged under the insulation due to water ingress and it was not inspected for many years.

The holes were sealed by using Belzona 1161 supported with metal wire mesh

A replicated steel plate was fabricated and bonded over the entire affected area.

Application completed after top coated with Belzona 5831 in two coat system.
