# Containment Pond

**Industry:** General Industry  
**Application:** TCC-Tanks and Chemical Containment Areas  
**Substrate:** Concrete  
**Products:** Belzona 3121 (MR7), Belzona 5231 (SG Laminate)

**Customer Location:** Dayton TN  
**Application Date:** June 2023

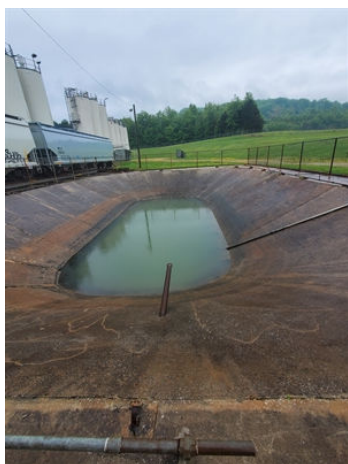
The containment area was very old and was suffering issues with cracking. The containment area was not in use but looked really bad for the inspectors of the plant. They wanted to save the area in case they decided to use it.

Containment area before restoration.

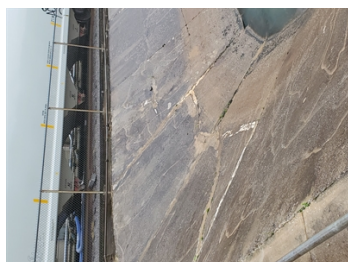
Cracks on the side of the containment area

The contractor pressure washed the area and used a pump to remove the water. The cracks were repaired with Belzona 3121 and reinforcing cloth 9331. Then two coats of Belzona 5231 were applied.

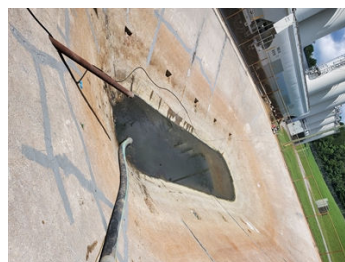
Cracks being repaired with Belzona 3121

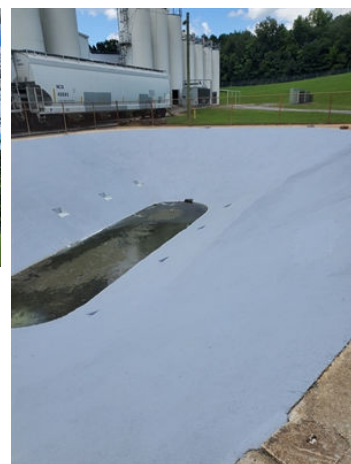
Containment area finished with two coats of Belzona 5231
