Sand Filter Repair

ID: 9534

Industry: Steel & Metal Processing
Application: TCC-Tanks and Chemical Containment Areas
Substrate: Carbon steel
Products: Belzona 1161 (Super UW-Metal), Belzona 1212, Belzona 1982 (SuperWrap II), Belzona 4111 (Magma-Quartz), Belzona 9611 (ES-Metal)

Customer Location: Gallatin TN
Application Date: August 2021

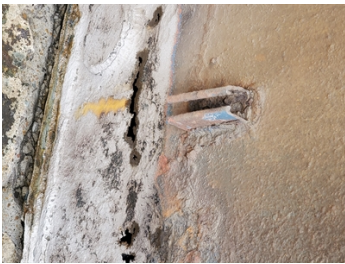
The filter tank was leaking in several areas. The base of the tank had very thin walls. It was in such bad shape it was unsafe to do the repairs from the inside.

Damage on the tank.

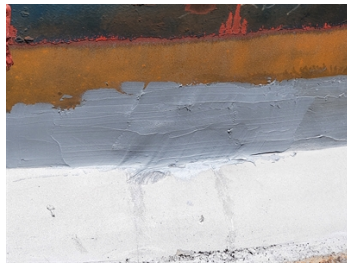
Application of Belzona 4111.

The area around the bottom of the tank was cleaned and Belzona 4111 was applied around the base of the tank. The metal was prepped any wet area we used Belzona 9611 to stop the leaks and Belzona 1161 and reinforcing cloth was used to fill in any voids and holes. then 1982 Superwrap was used around the bottom part of the tank to cover the 1161.

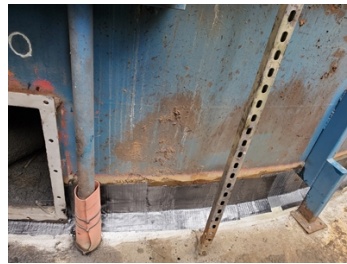
The base of the tank surface is prepped.

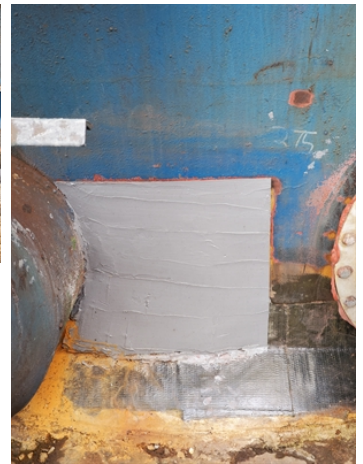
Finished application.
